Service Bulletin

Bulletin No.: 23-NA-102

Subject: Drivability Concerns, Hesitation, Transmission Shifting Rough/Harsh, Malfunction Indicator Lamp (MIL) Illuminated - Multiple DTCs Set

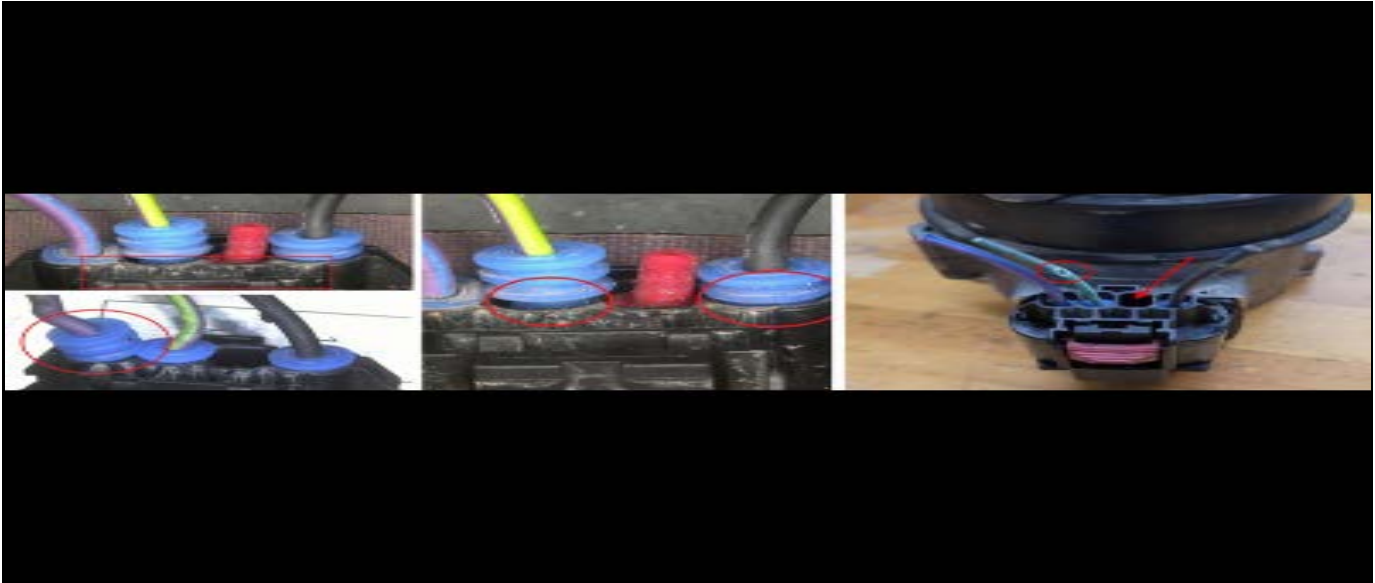
6219342

Area of Concern at the CAC Pump Electrical Connector

An open cavity or an unsealed pump connector allowing water into the (M10) charge air cooler pump electrical connector might be the root cause of the communication failure.

- Check the CAC Pump connector sealing and look for any corrosion at the pump due to water leakage.

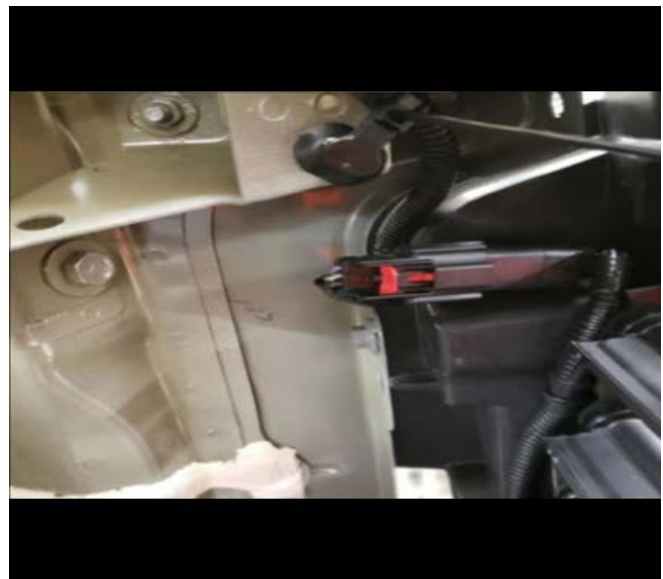
6219339

Area of Concern Active Grille Air Shutter Actuator In-line Connector

The following DTCs may be caused by the engine wiring harness to active grille air shutter actuator in-line connector (X618 on the pickup and X604A On the SUV). Please check circuit 4621 which may be:

- Not properly connected
- Not properly held by the rear clip
- Grounded on the radiator

The graphic above shows how the proper connection must be.

- Check the active grille air shutter actuator in-line connector for not being properly connected or grounded to the radiator.

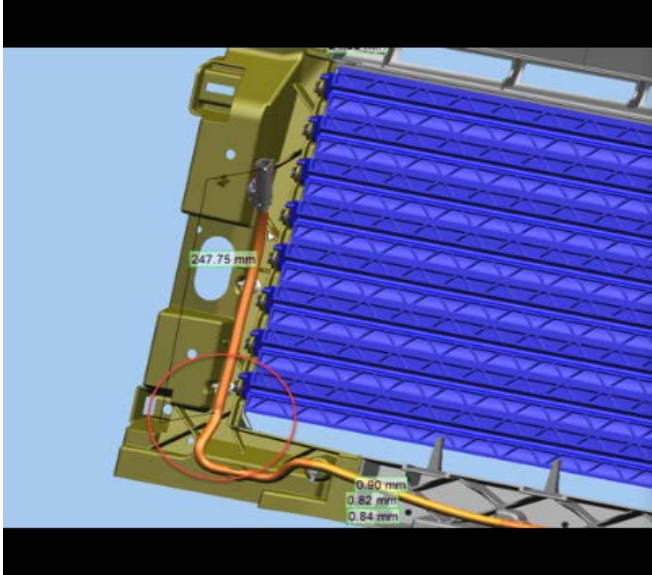
6219340

DTCs may be caused by the active grill air shutter wiring pinched at the radiator support.

The graphic above depicts where a pinching condition may be located.

- Check the active grill air shutter wiring route to identify possible damaged points in the wiring.

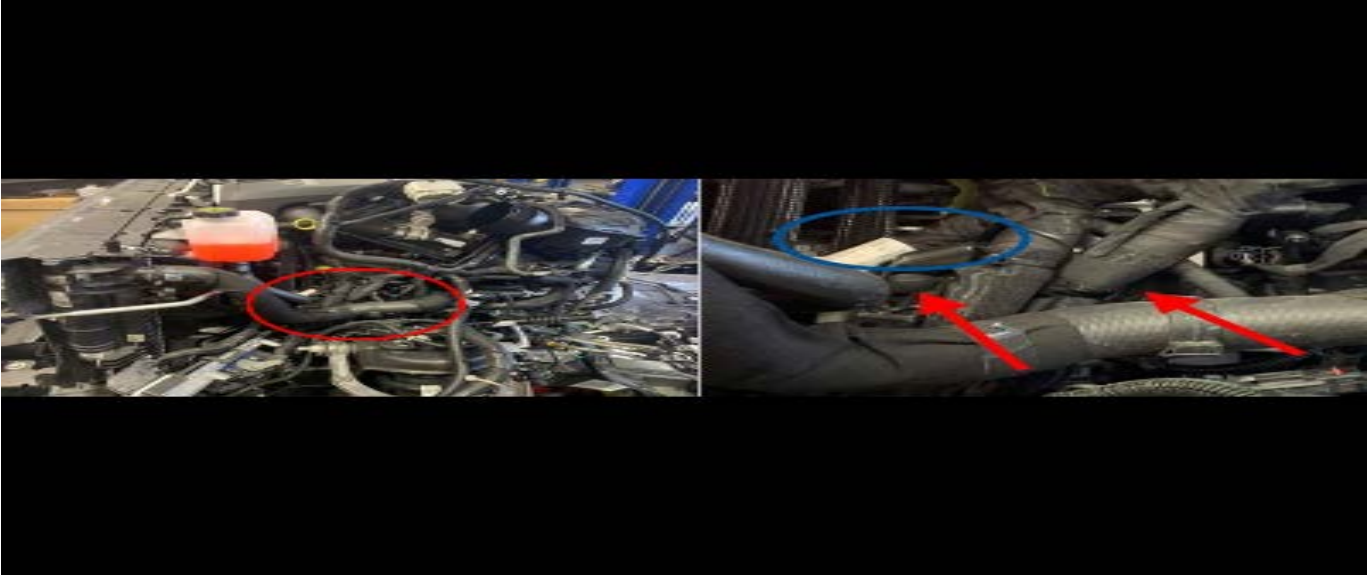
6357536

LM2 Area of Concern at Alternator Bracket

- Arrows indicate location of retainer pins that were not properly installed.
- Blue circle indicates where a chafe in the wiring has occurred. The mis-installed bracket allowed the harness to lay on the alternator.

Note: Using Woven Polyester Electrical Tape (PET), tape all the contact points of the wiring harness ensuring that the tape is applied in a double layer extending along the harness past the splice sleeves. Verify all straps are secured and retainers are installed.

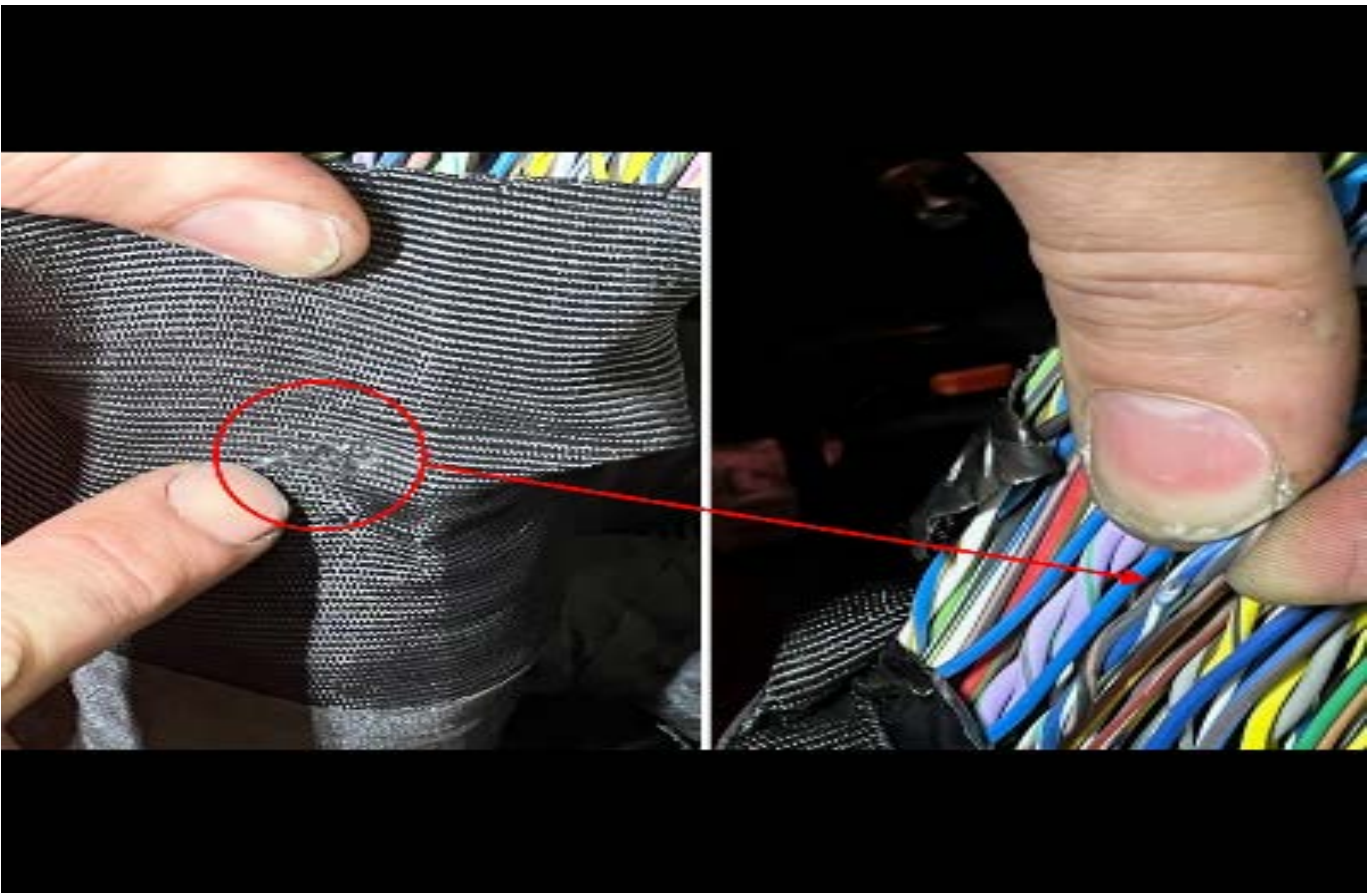
6357529

LM2 – Wiring Harness Contact at Alternator Bracket.

- The engine wire harness was chafed by a bracket next to the back of the alternator.

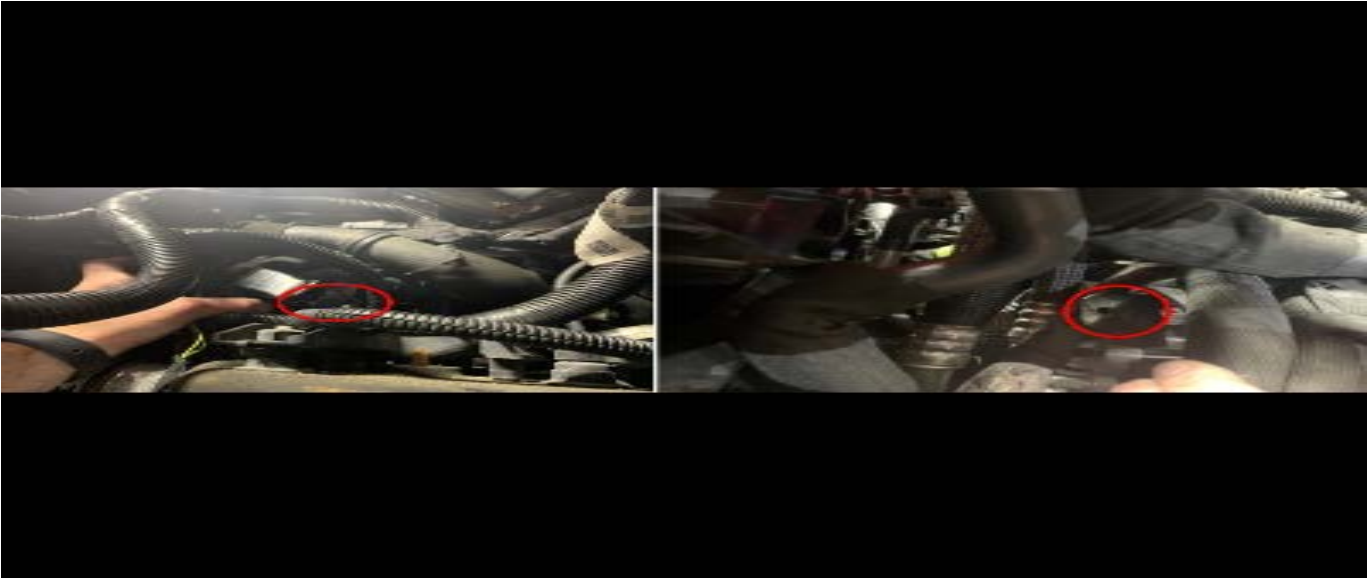
6357546

U0073 CAN BUS 2 off or U0074 CAN BUS 3 off

LM2 – TCCM Wiring Harness Contact at A/C Line and Bracket near Alternator.

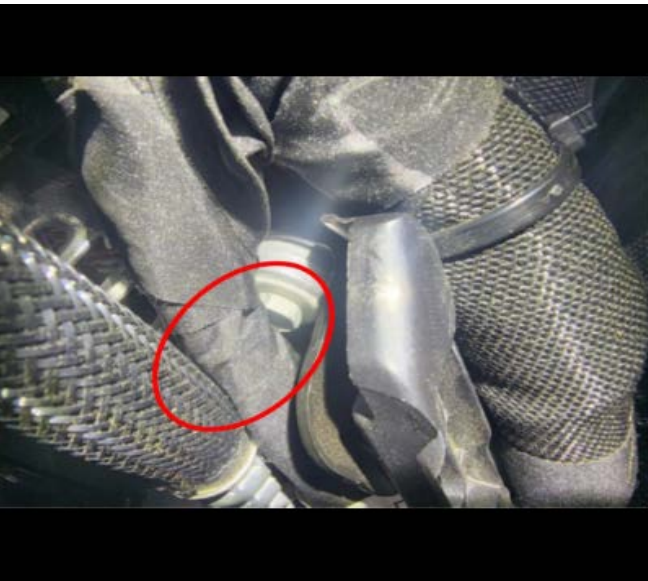
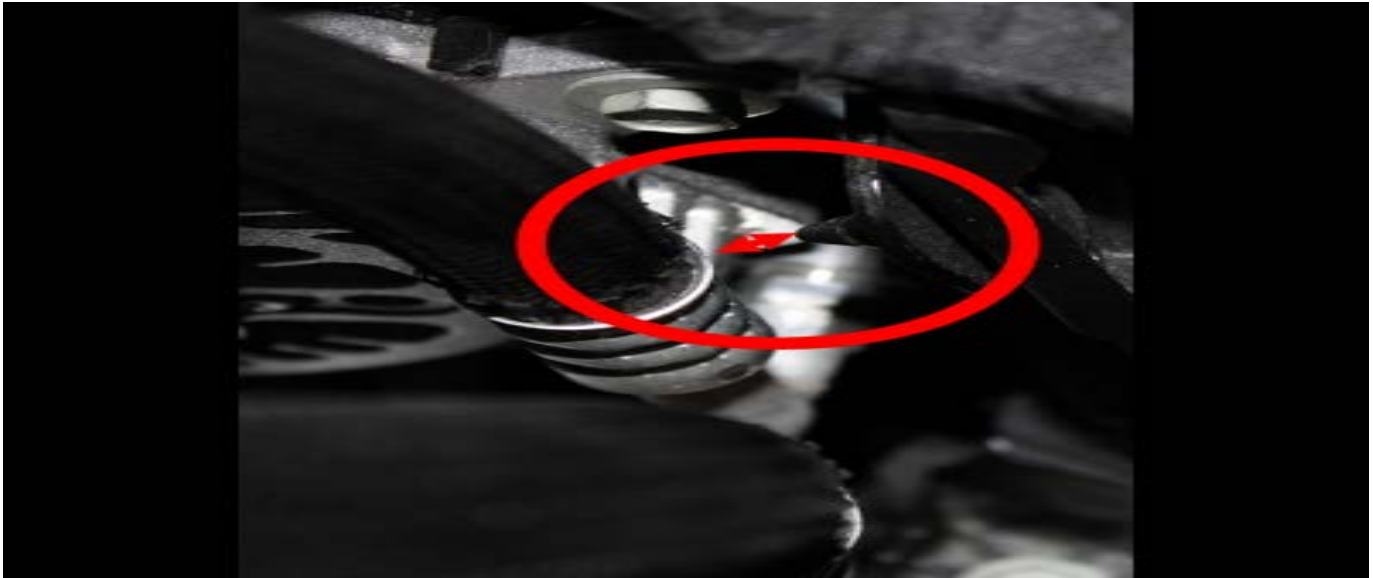
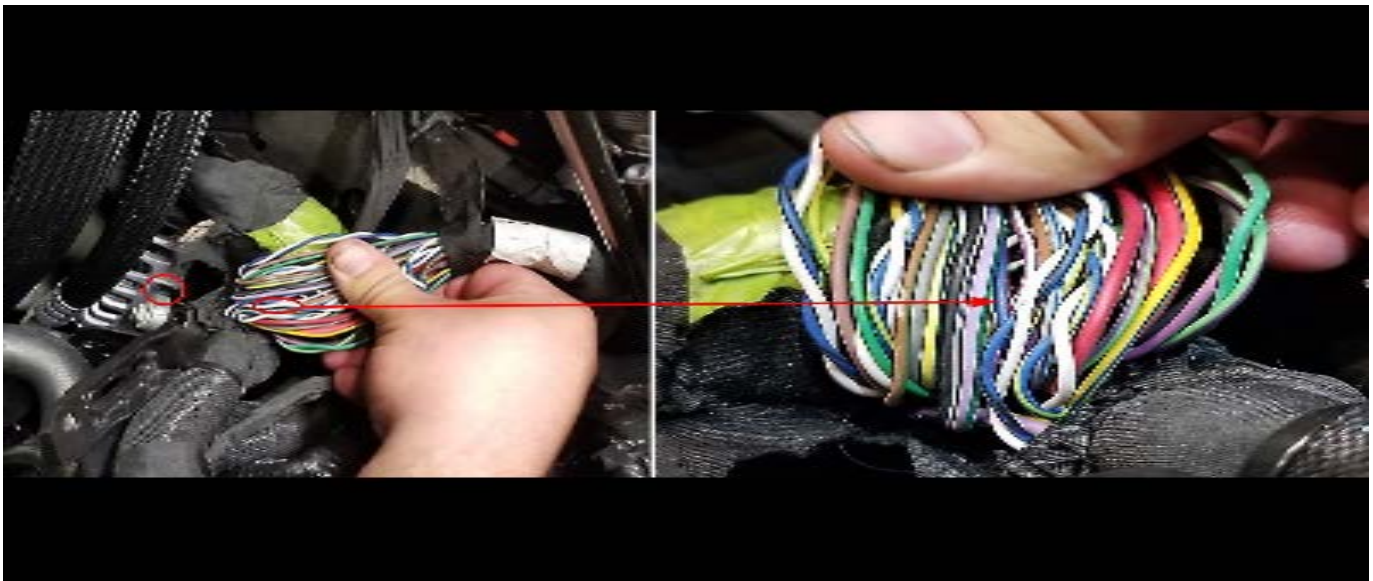
LZ0 Area of Concern at Alternator Bracket

LZ0 – The Wiring Harness Contacted the Alternator Bracket do to Routing of the Harness.

Note: During the repair. It was noted that a 5/8 ths diameter hose was used to prevent a reoccurring chafe condition.

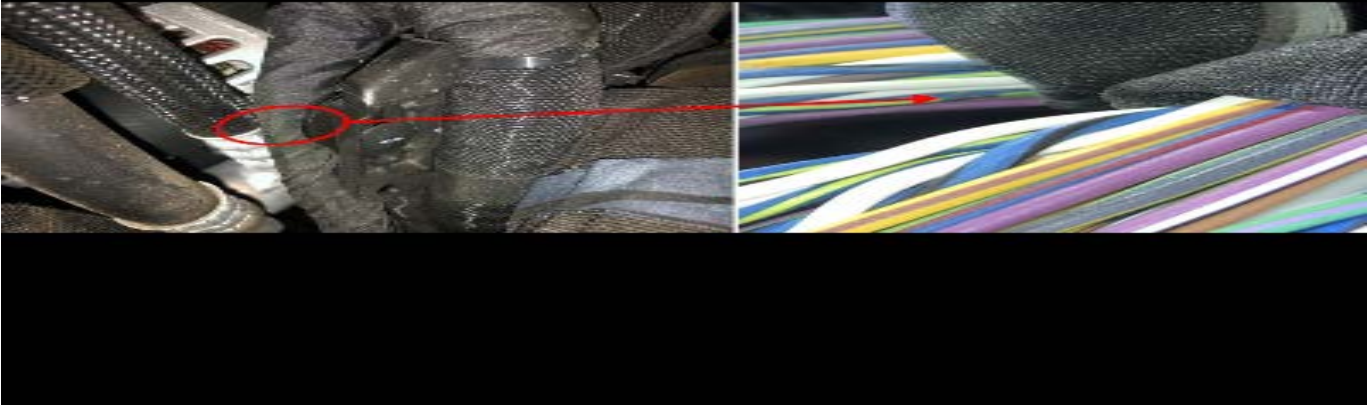
6357567

This is CAN 3 wire harness. Can 4 is also in this bundle only blue and yellow twisted with white.

LZ0 – Wiring Harness Contacting the A/C Line and Alternator Bracket.

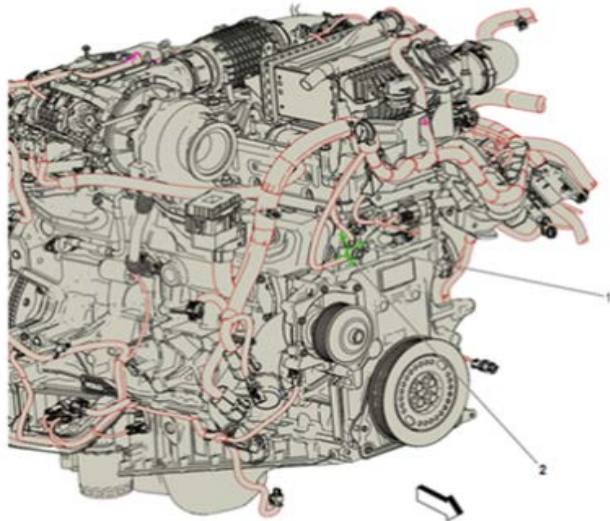
6400093

Loose Ground

Inspect ground connections G176A (1) and G177B (2) may exist. Please check for any:

- Loosen condition
- Damaged or dirty threads
