WNM8 – Reworking Threaded Bush on Rear-End Strut (Workshop Campaign)

Revision: This bulletin replaces bulletin Group 4 168/22 WNM8, dated September 30, 2022.

Model Line: **Panamera (971)**

Concerns: **Threaded bush on rear-end strut**

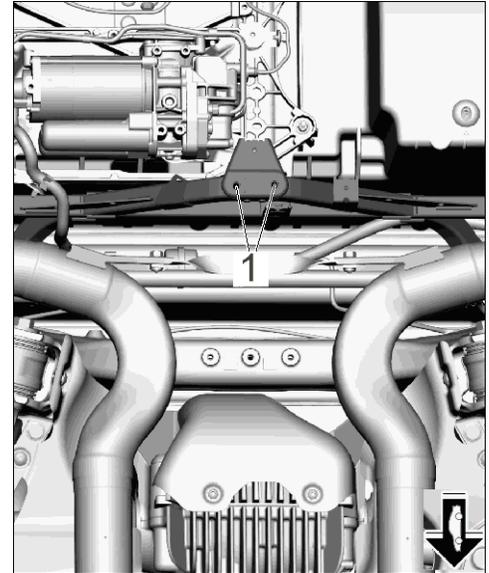
Threaded bush for rear end strut

Information: **There is a possibility that the fastening screws on the rear end strut on the affected vehicles were not tightened to the specified tightening torque.**

This can result in acoustic problems (rattling noises) in the rear end area.

- 2 Rework ⇒ *Threaded bush for rear end strut -1-* threaded bushes for rear end strut (hash).
- 3 Installing rear end strut (hash). For instructions, see ⇒ *Workshop Manual '421319 Removing and installing strut'*
Replace ⇒ *Threaded bush for rear end strut -1-* both rear screws for the new threaded bushes on the rear-end strut (hash) and tighten to the prescribed tightening torque.
- 4 Enter the campaign in the Warranty and Maintenance booklet.

Tightening torque 25 Nm (18.4 ftlb.)
