TECHNICAL SERVICE BULLETIN

Classification: EL23-009A	Reference: NTB23-060A	Date: August 4, 2023
------------------------------	--------------------------	-------------------------

WIRELESS CHARGING PAD HAS INTERMITTENT OPERATION WITH APPLE IPHONE 12 OR NEWER

APPLIED VEHICLES: 2023 ARIYA (FE0)

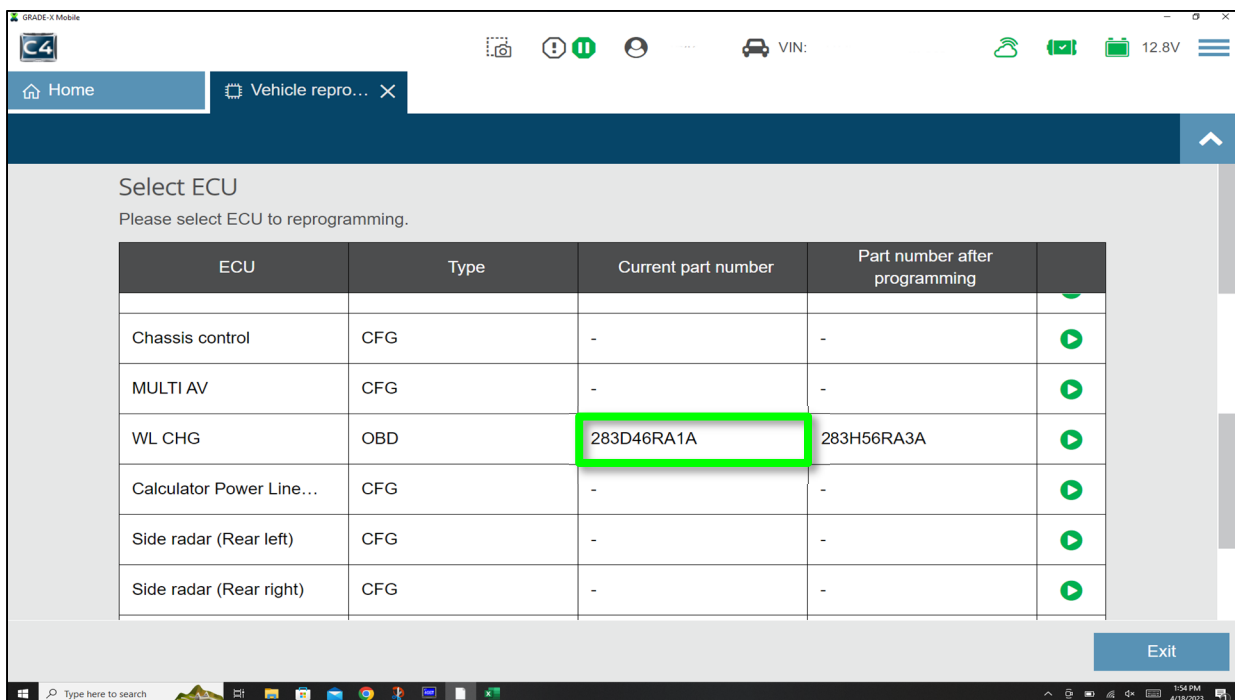
Figure 3

10. Find the **Current part number** of the Wireless Charger ECU (**WL CHG**) and write it on the repair order.
 - If the **Current part number** matches one of the part numbers in the **CURRENT WIRELESS CHARGER PART NUMBER** column of **Table 1**, proceed to step 11 on page 5.
 - If the **Current part number** does not match one of the part numbers in the **CURRENT WIRELESS CHARGER PART NUMBER** column of **Table 1**, this bulletin does not apply. Return to ASIST for further diagnostic and repair information.
