TECHNICAL SERVICE BULLETIN

Classification: BT23-012	Reference: NTB23-063	Date: August 8, 2023
-----------------------------	-------------------------	-------------------------

POPPING NOISE WHEN OPENING BACK DOOR

APPLIED VEHICLES: 2023 Rogue (T33)
APPLIED VIN AND DATES: VINs starting with 5N1
and built on or before February 16, 2023

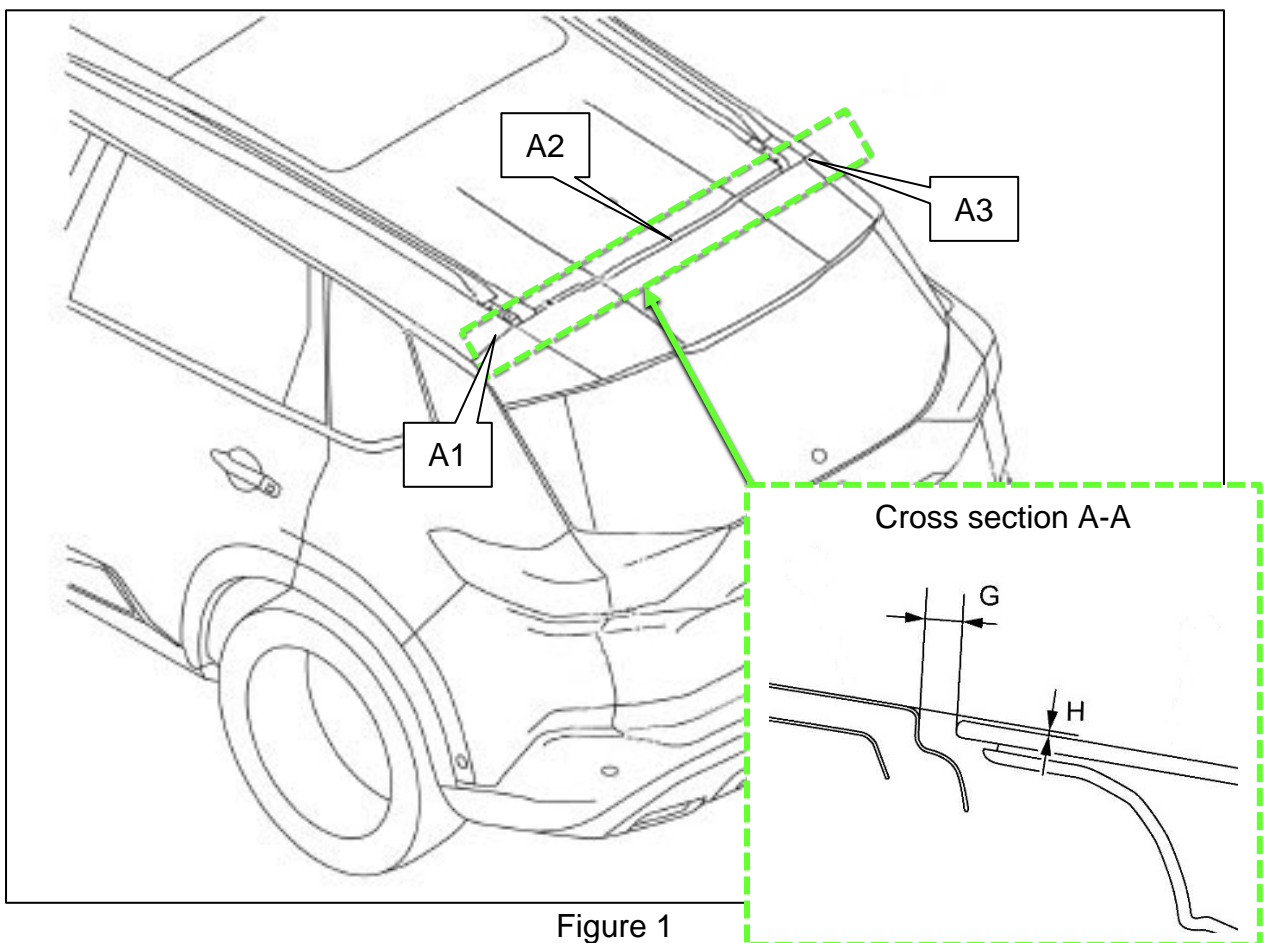
Figure 1

1. Inspect the vehicle's Back Door for correct alignment.
 - Measure the Back Door to roof gaps of "G" and surface height of "H" at points A1, A2, and A3, where defined in cross section A-A (Figure 1), write the measurements on the repair order.
 - The surface height of "H" should measure between -3.0 to +1.0 mm where negative refers to the Back Door spoiler surface being below the roof surface.

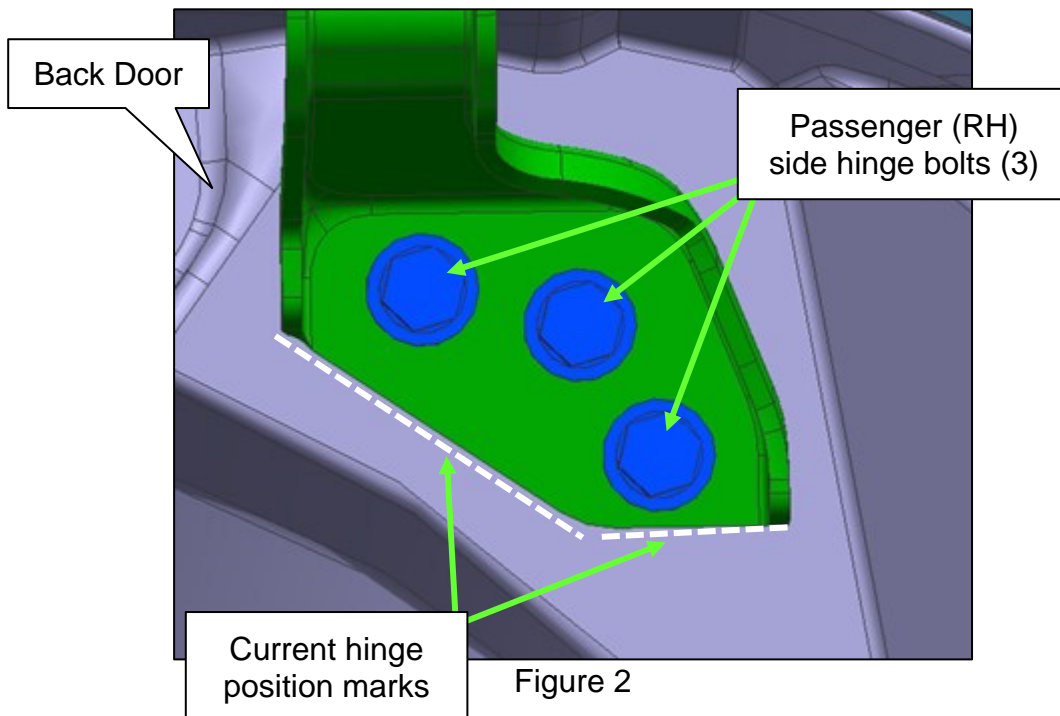
- Figure 2 is of the three (3) passenger side hinge bolts. The driver side is similar.

3. Open the Back Door and temporarily mark its current hinge positions, where shown in Figure 2, with something that is not permanent.

4. Loosen the six (6) hinge bolts (Figure 2 shows 3 of 6 bolts) located on both the driver (LH) side and passenger (RH) side, but do not remove.

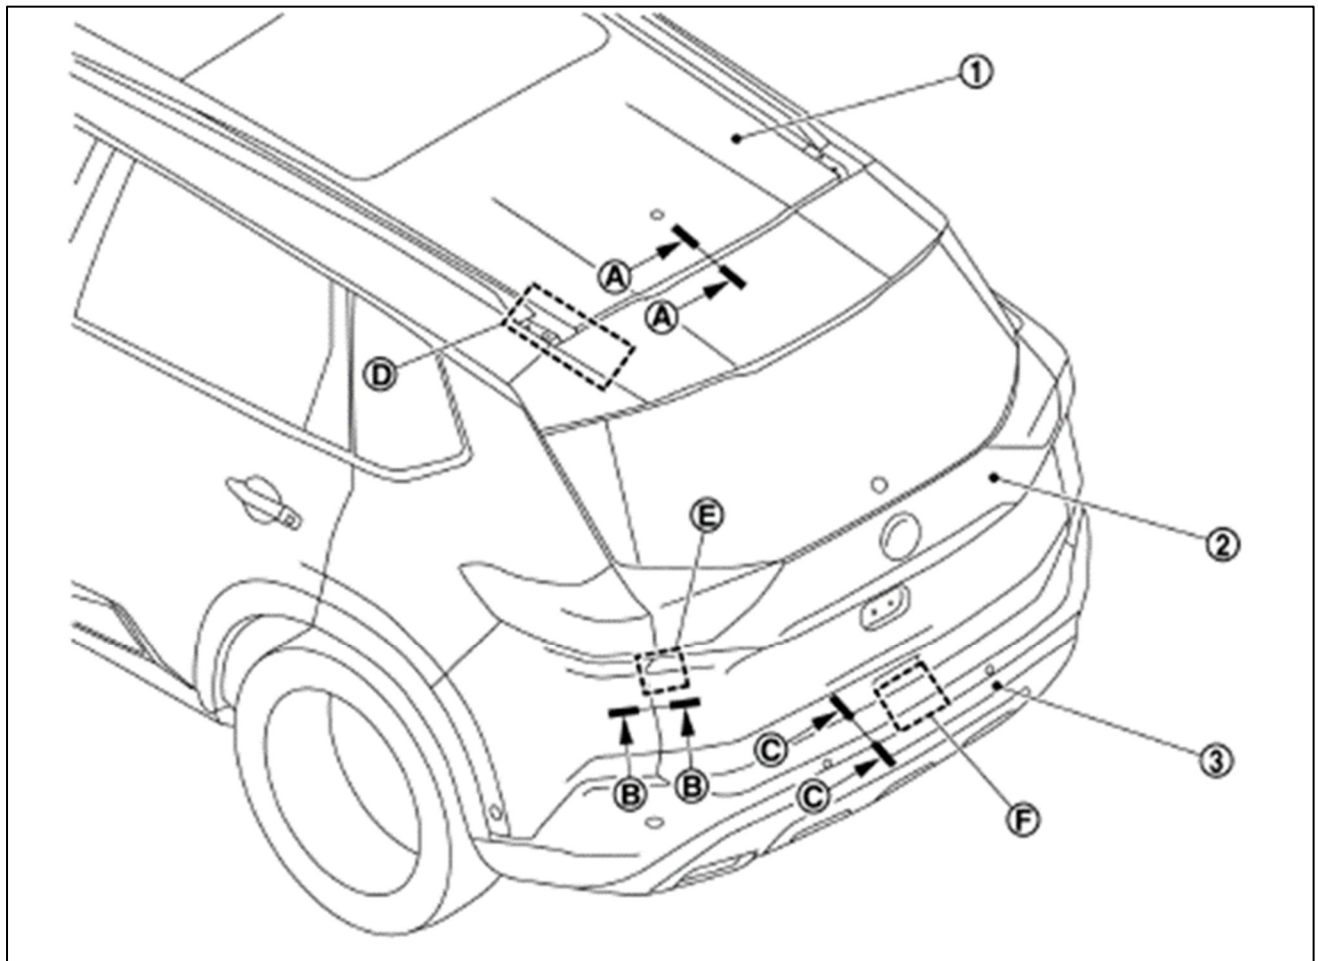
Figure 4 is of cross section locations.

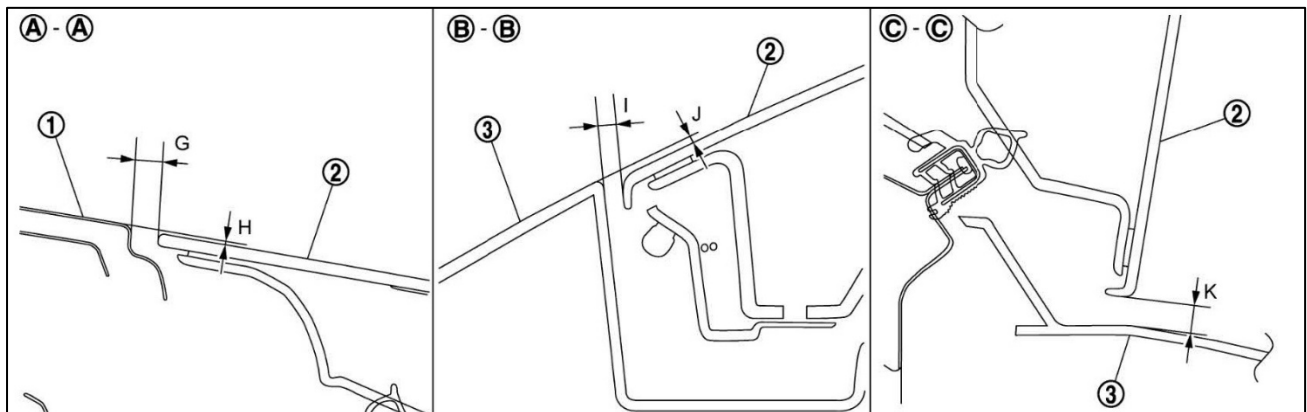
Figure 5 illustrates each cross section view and measurement points.

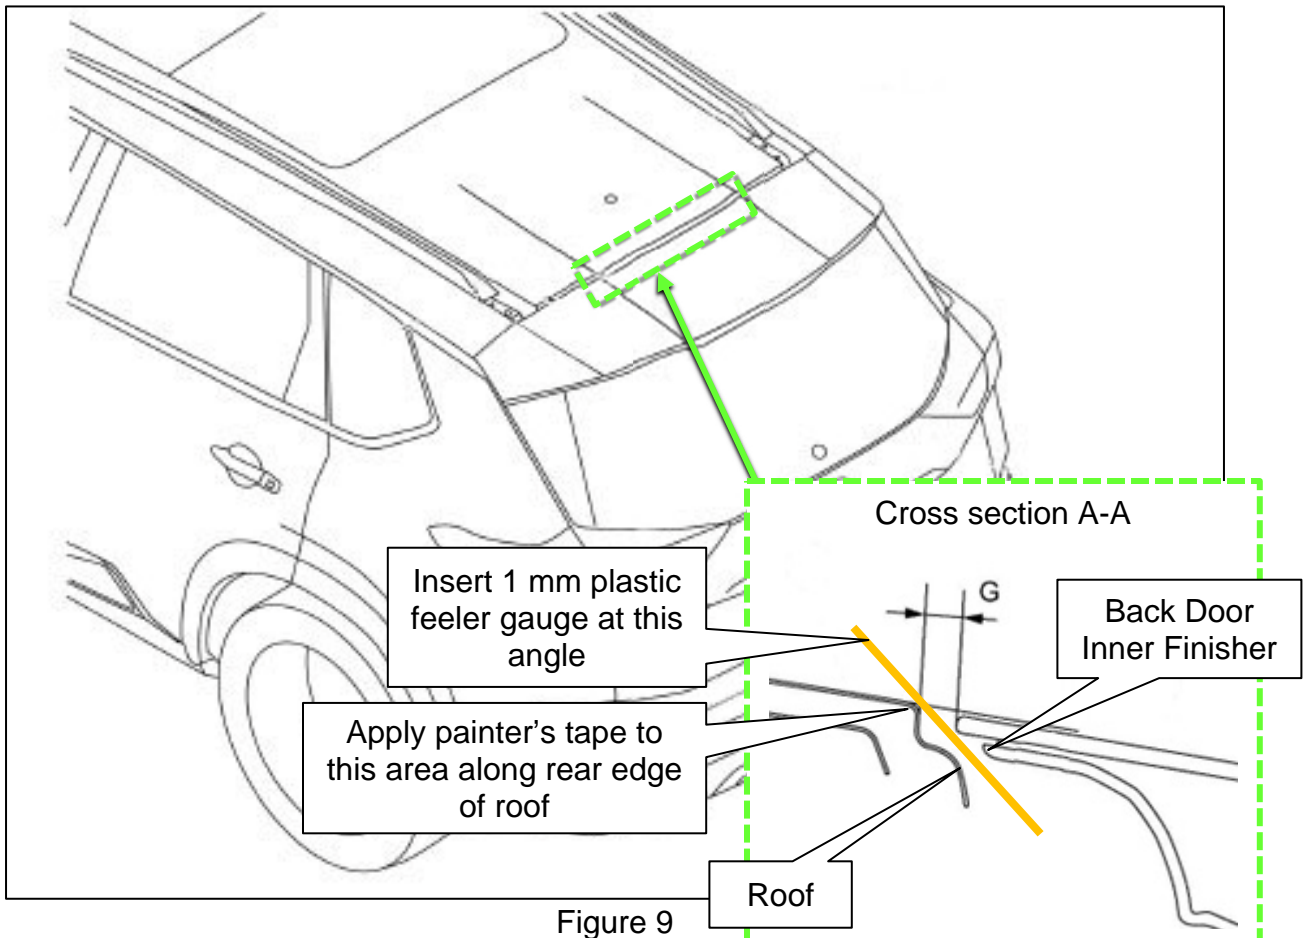
Figure 9

14. Close the Back Door and measure the gap between the Back Door Inner Finisher and the roof along the entire area shown in Figure 9, by inserting a flexible 1 mm plastic feeler gauge (Figure 8) or similar tool.

15. Document where the plastic feeler gauge could not pass through.

13. Apply painter's tape to the rear edge of the roof where shown in Figure 9, to protect the vehicle's paint.

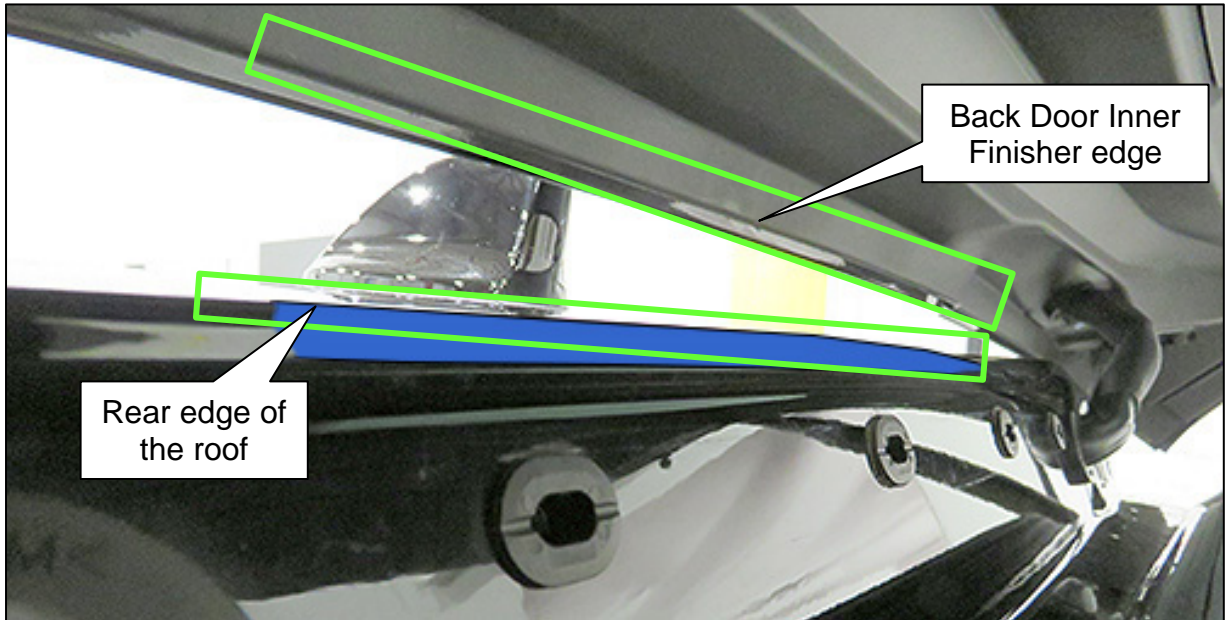
Figure 10

16. Open the Back Door and examine the edge of the Back Door Inner Finisher and the rear edge of the roof (where shown in Figure 10) for evidence of rubbing, where the plastic feeler gauge could not pass through.
