Spartan Fire, LLC

Technical Service Bulletin
TSB23-560-003

APPLIES TO: This service bulletin applies to certain 2022 through 2024 model year, Gladiator, Metro Star, and FC-94 model emergency response chassis cabs built between December 2022 and April 2023.

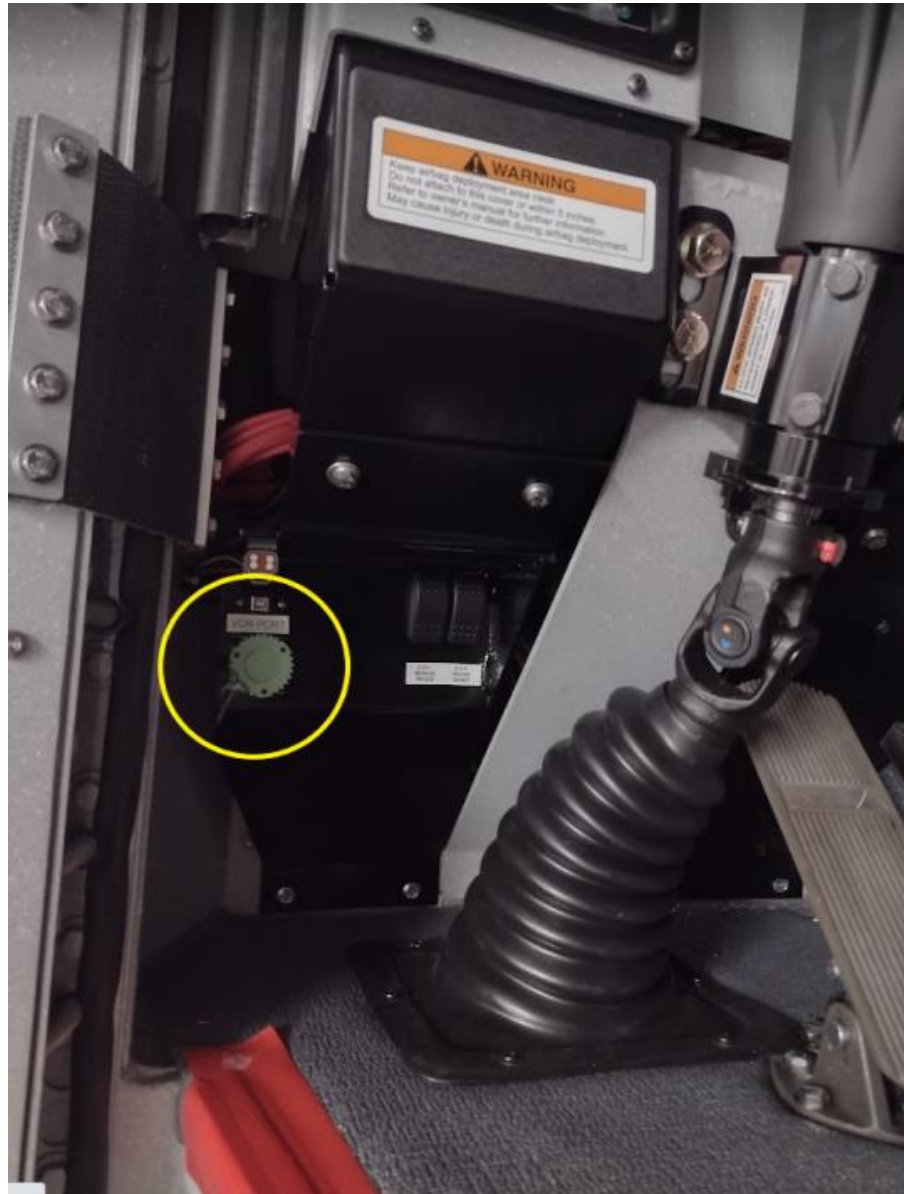
Figure 2.1

1. Locate the datalink connector under the driver's side dash location as shown in *figure 2.1* below.

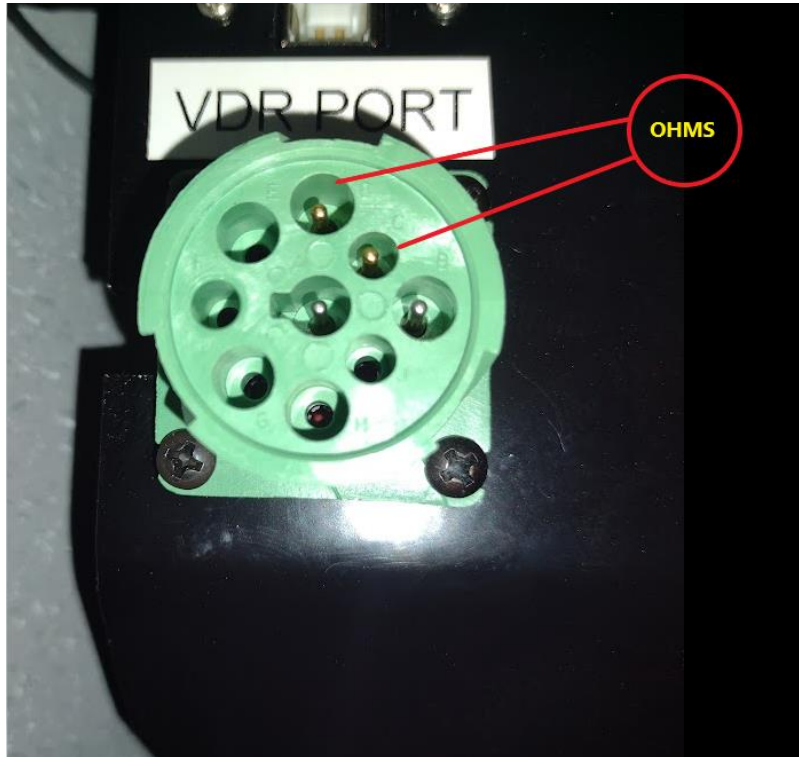
Figure 3.1

2. With the master and ignition switches turned off, use a DVOM (Digital Volt Ohm Meter) to measure the resistance between pins C & D. See *Figure 3.1*

3. If approximately 60 ohms is measured, no further action is required. Do not proceed with the rest of the instructions. Unit can be put back in operation.
4. If the measurement is around 40 ohms, this indicates the Smart Dual Pressure Transducer (SDPT) could be equipped with its own terminating resistor, and it may require replacement with one that does not have a terminating resistor.

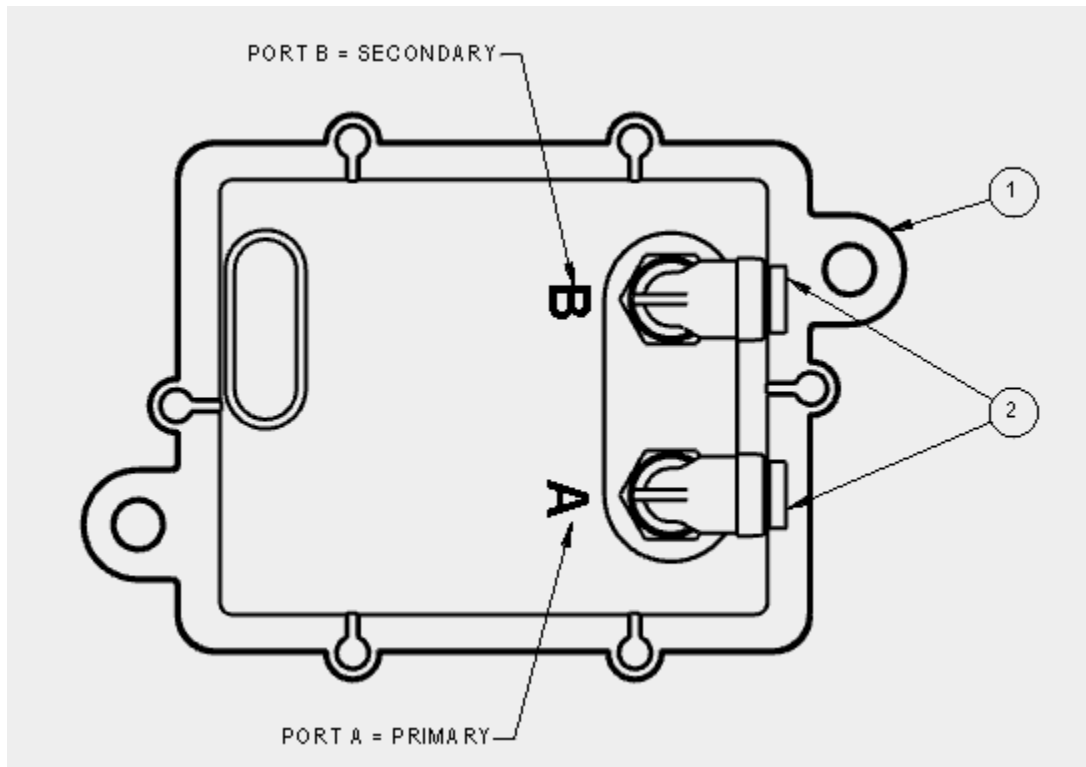
Figure 5.1

7. Disconnect electrical connector from SDPT module.
8. Check resistance again between pins C & D of the diagnostic connector as shown in Figure 3.1 to confirm SDPT module is the issue.
 - a. If resistance is still 40 ohms with the SDPT connector disconnected, the SDPT is not the issue and there is another terminating resistor in the circuit that will have to be addressed. Reinstall connector and headlight assembly. Contact Spartan Customer Service (1-800-867-6478) for further assistance. Do not proceed any further with the instructions below.
 - b. If resistance is now at 60 ohms with the SDPT connector disconnected, proceed with SDPT replacement beginning in step 9.
9. Disconnect primary and secondary air lines from SDPT module. Note the orientation of the lines to the ports. *See Figure 5.1*

10. Remove two fasteners holding module to the firewall and remove the module.
11. Install new SDPT module with the two original fasteners.
12. Reconnect electrical connector.
13. Reconnect the airlines to the appropriate ports. (Primary line to port A and Secondary line to port B.)
14. With DVOM (digital volt ohm meter), recheck the resistance between pins C & D and confirm resistance value is now 60 ohms.
15. Start engine and verify there are no air leaks and that the gauges work correctly.
16. Reinstall headlight assembly.
