## **Service Bulletin**

Bulletin No.: 23-NA-137

**Subject:** Information on Transmission Case Flange Interference

Brand:	Model:	Model Year:		VIN:		Engine	Transmission:
		from	to	from	to	Engine:	Transmission.
Cadillac	СТ6	2016	2020	_	_	_	8–Speed Automatic (RPOs M5N, M5X)

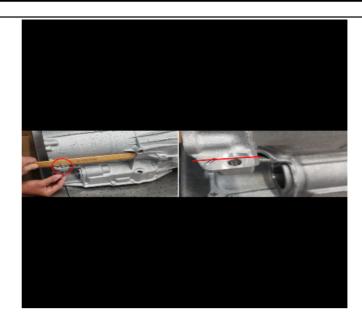
6403175

Involved Region or Country	North America	
Condition	Some technicians may find it difficult to install the front propeller shaft due to contact with a flange located on the transmission case.	
Cause	This condition may be caused by a transmission case used on multiple vehicle platforms that require this flange to support a heat shield.

Note: Graphic depicts transmission removed from vehicle for clarity.

The technician will need to remove the flange by cutting it off with one of the identified cutting tools:

- 1. Utilizing a straight edge or equivalent, mark a straight line across the flange as shown in the graphic above.
- 2. Utilizing a cutoff tool or equivalent, cut along the line.
