# Service Bulletin

Bulletin No.: 23-NA-141

**Subject:** Information on Engine Block Cracked at Head Bolt Hole Locations

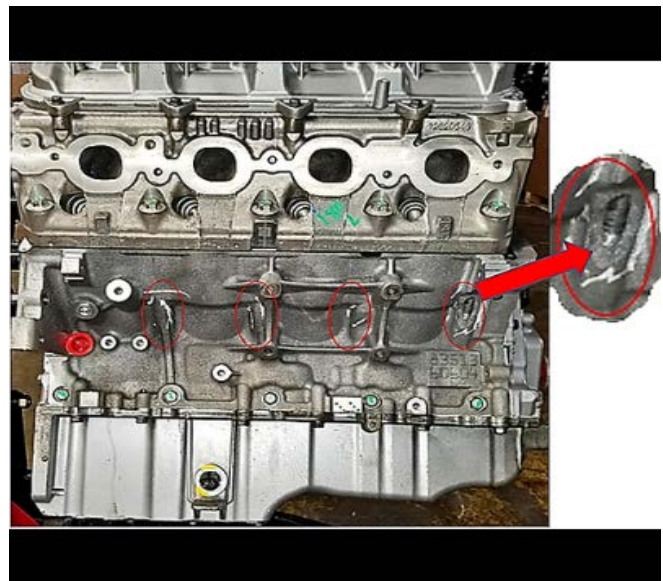
6407761

**Engine Block Damage caused by Foreign Debris, Dirt, or Coolant Left in the Cylinder Head Bolt Holes**

The engine block may be cracked or damaged if debris, dirt, or coolant is left in the cylinder bolt holes of the block, or if the threads are damaged when installing the head bolts during any service repair that requires removal, installation, or replacement of the cylinder head. (See GenV engine photos below as example).

The head bolt holes in the block are being damaged due to coolant, dirt, or debris being present in head bolt holes during cylinder head installation during a repair, or when re-assembling the engine for core return.

If coolant, dirt, or debris is present in the bolt holes during assembly, the foreign material will create a hydro-lock condition that will over-pressurize the casting column of the threaded hole in the block, causing the casting to break as shown in the graphic above.

- Clean all dirt, debris, and coolant from the engine block cylinder head bolt holes. Failure to remove all foreign material may result in damaged threads, improperly tightened fasteners, cause damage to engine block, or other components.
- Clean bolt holes using spray solvent, and compressed air.
- Inspect/repair threads of head bolt holes per SI repair procedures.
