# Service Bulletin

Bulletin No.: 23-NA-058

**Subject:** Cold Start Rattle Noise from the Engine Compartment, Malfunction Indicator Lamp (MIL) Illuminated - DTC P0299 Set

Brand:	Model:	Model Year:		VIN:		Engine:	Transmission:
		from	to	from	to		
Buick	Encore GX	2020	2023			1.2L (LIH)	
Chevrolet	Trailblazer	2021

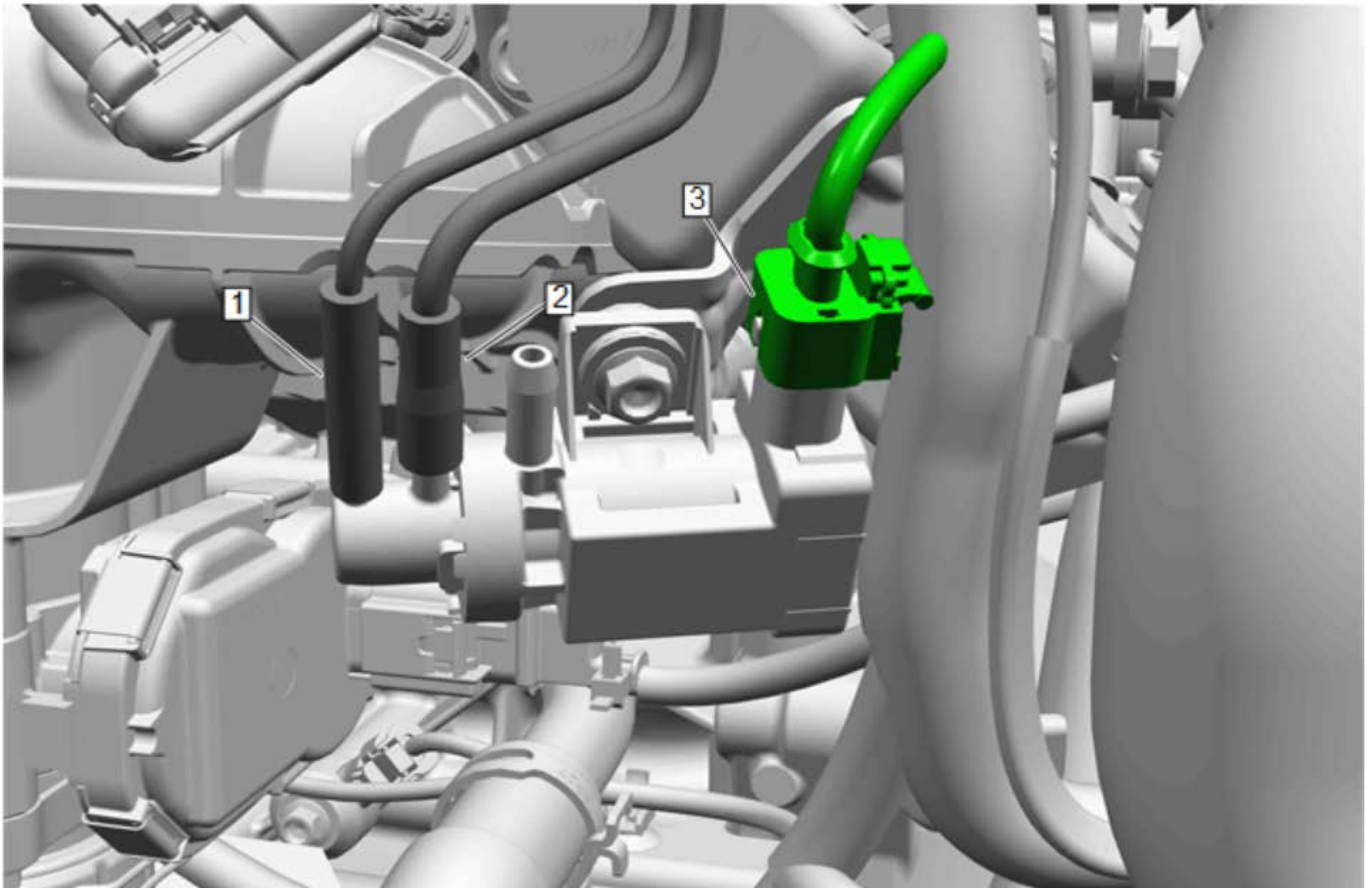
5392518

1. Disconnect the Turbocharger Wastegate Actuator Vacuum Control Solenoid Valve Hose (1) from the Turbocharger Wastegate Regulator Solenoid Valve.
  2. Utilizing EN-23738-A Vacuum Pump with an integral vacuum gauge, connect said pump to the Turbocharger Wastegate Actuator Vacuum Control Solenoid Valve Hose.

3. Engine at operating temperature at idle.
  4. Verify the tool reading: EN-23738-A Vacuum Pump = -50 kPa (-0.5 bar, 15 in Hg).
    - If the desired pressure/vacuum cannot be achieved or does not hold steady:

- ⇒ Ignition/Vehicle » Off.
- ⇒ Test or replace the component: Vacuum Pump Assembly and related hoses.
- If the desired pressure/vacuum can be achieved and holds steady:

- Engine » Off.
    - Reconnect the Turbocharger Wastegate Actuator Vacuum Control Solenoid Valve Hose to the Turbocharger Wastegate Regulator Solenoid Valve and refer to Check Wastegate Vacuum Regulator Valve Function.
