Service Bulletin

Bulletin No.: 22-NA-187

Subject: Information on Service 4WD Light Intermittently Displays On the Drivers Information Center (DIC) and Will Not Engage when Selecting 4WD - DTC C11B9, C05FB, C15C1, C15AB, U0422-71 and/or U0401-71 Set

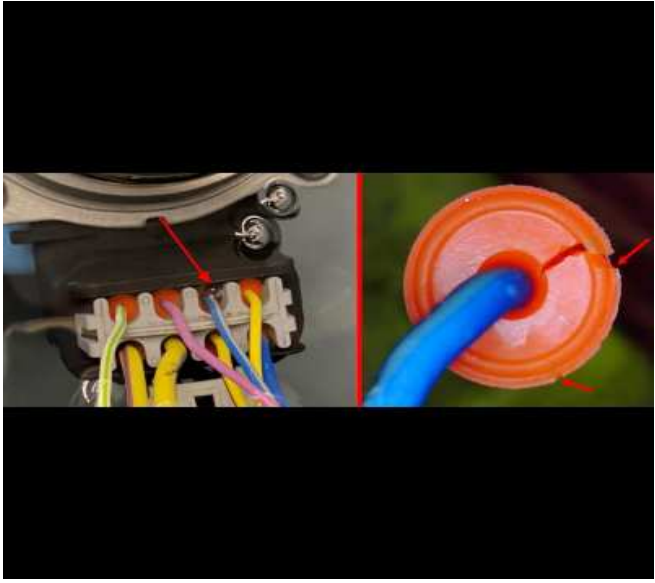
Involved Region or Country	North America
Condition	<p>Some customers may comment that the Service four-wheel drive light will intermittently display on the DIC and will not engage when selecting four-wheel drive.</p> <p>Some technicians may find one or more DTC set:</p> <ul style="list-style-type: none"> • C11B9 • C05FB • C15C1 • C15AB • U0422-71 • U0401-71
Cause	<p>This condition may be caused by potential water intrusion at the Transfer Case Actuator connector on the harness side.</p> <p>– The grommet may be cracked or torn.</p>
Information	<div style="text-align: center;">

</div> <p style="text-align: right; margin-right: 20px;">6151017</p> <p>Inspect the transfer case electrical connector and the transfer case connector on the actuator motor for signs of corrosion. This may indicate that a grommet in said connector may be damaged as shown in the graphic above.</p> <p>– If there are signs of corrosion or damage to the grommet, replace the electrical connector and refer to SI for repair.</p>

Refer to *Wire to Wire Repair in SI* and *Repairing Connector Terminals in SI*.

Causal Part	Description	Part Number	Qty
X	CONNECTOR KIT, ENG WRG HARN	19369184	1
