# Service Bulletin

Bulletin No.: 20-NA-100

**Subject: Engine Control Module Calibration for T1 L3B Engine with DTC P26BB Set**

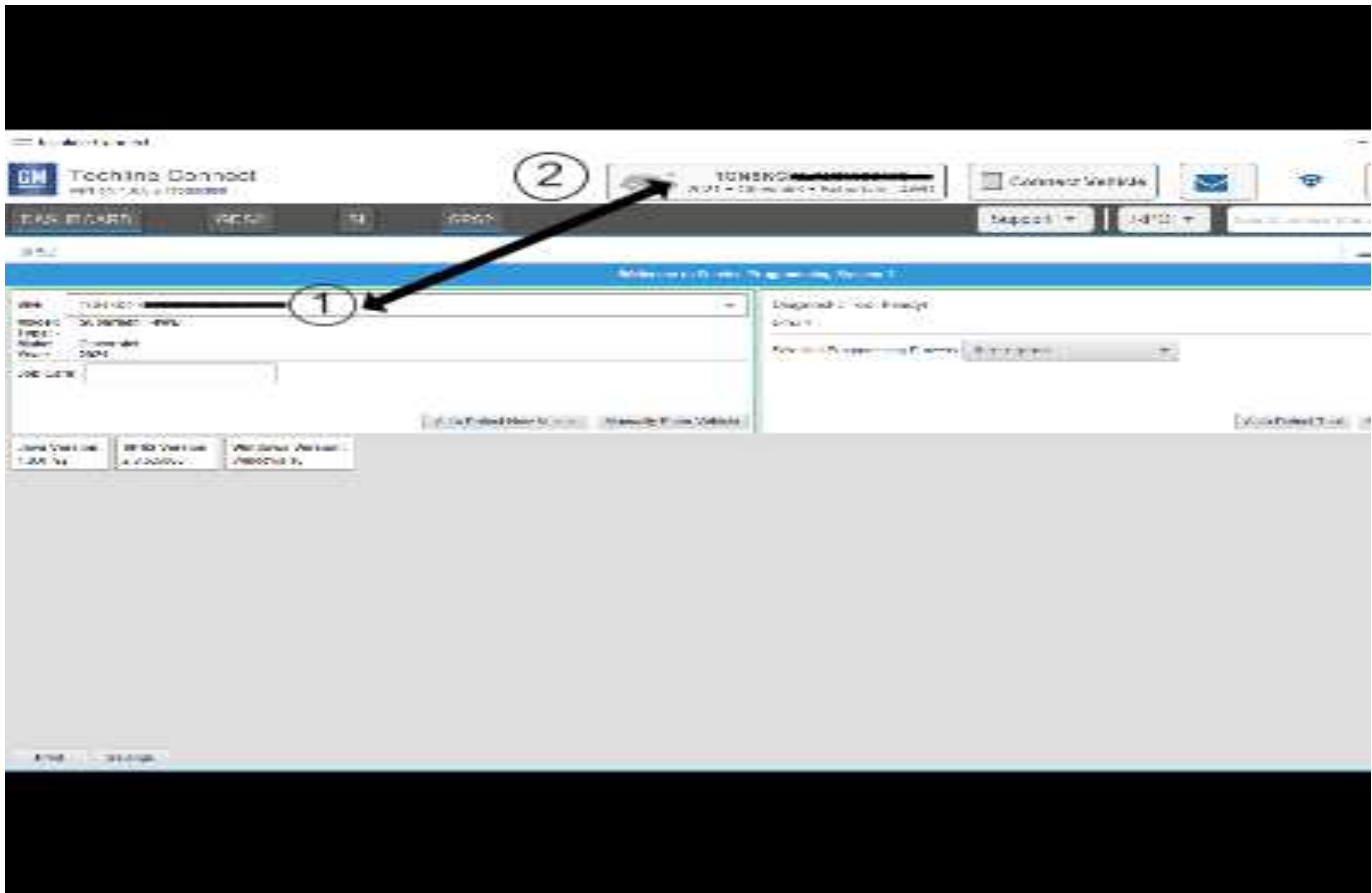
5877000

**Caution:** Be sure the VIN selected in the drop down menu (1) is the same as the vehicle connected (2) before beginning programming.
