Preliminary Information

PIP5853E TCCM Drivability DTCs and Possible Low Battery Charge Models

Brand:	Model:	Model Years:	VIN:		Engine:	Transmissions:
			from	to		
Chevrolet	Silverado 4500HD, 5500HD, 6500HD	2019 - 2023	All	All	All	All

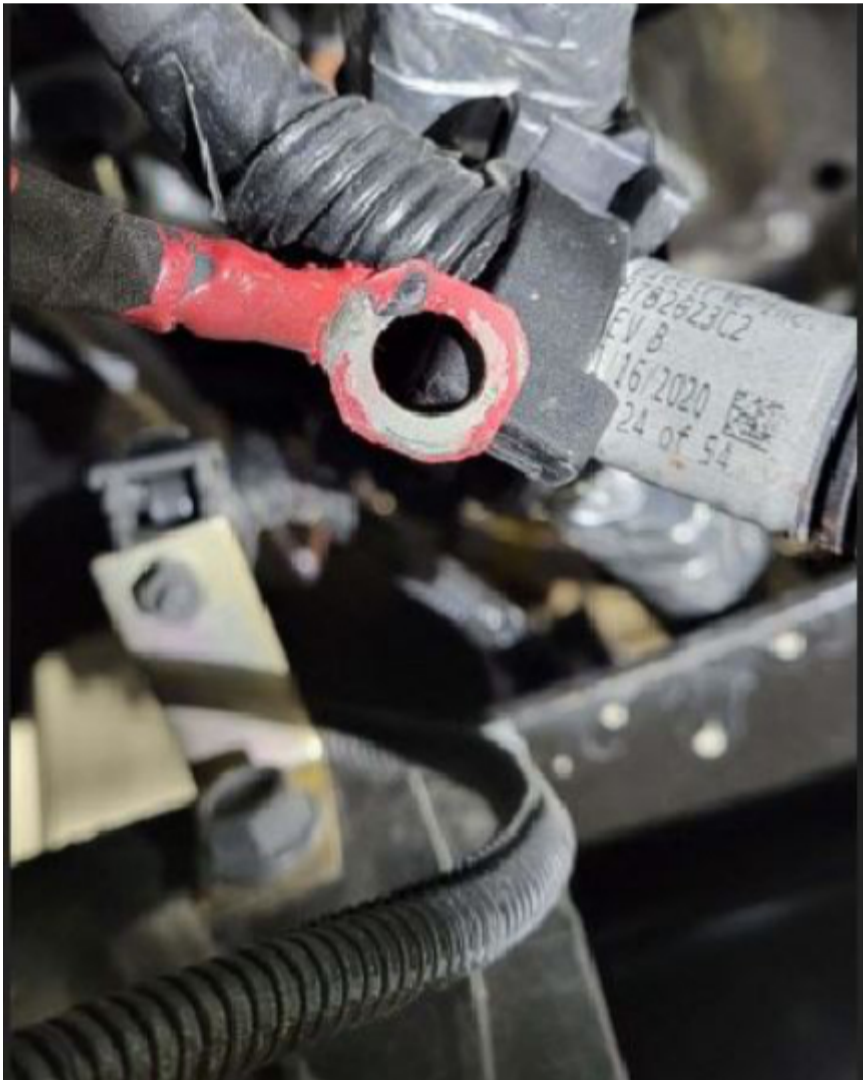
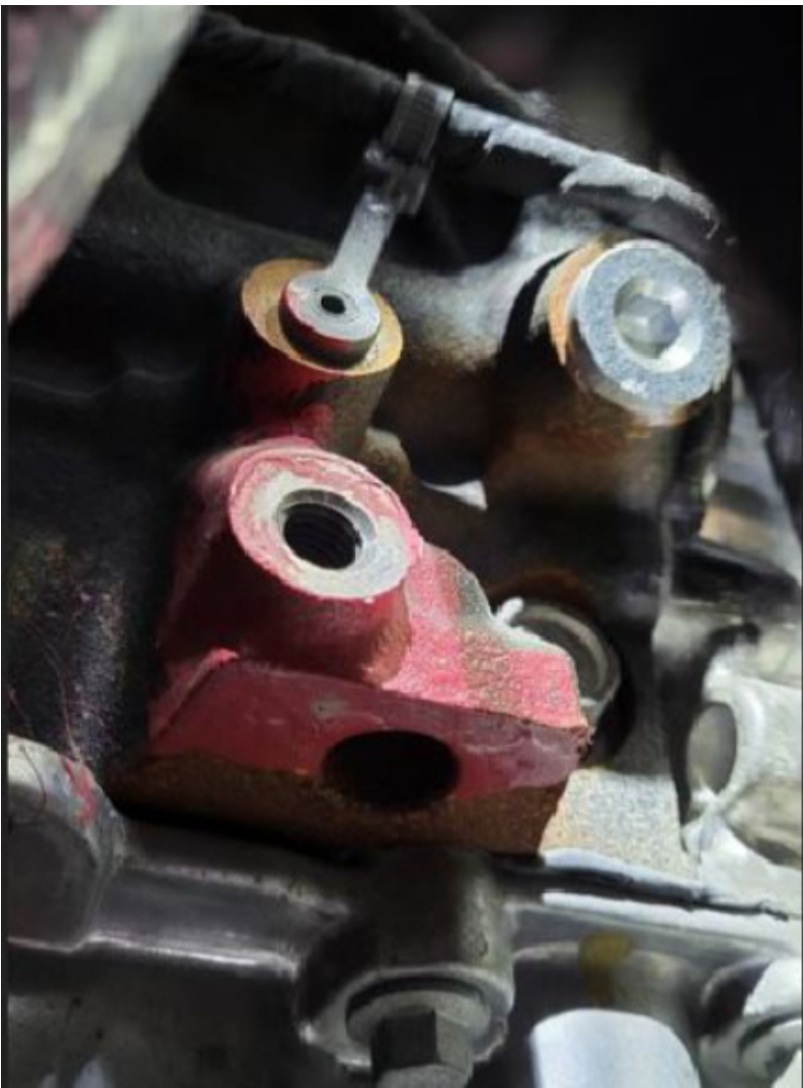
Also, there may be an issue at G110

This ground may be loose; however, it will feel tight due to the anti-corrosion paint that has been applied. This paint will not only make the ground feel tight but will also seep behind the ground and cause a poor connection

If no concern is seen with the ignition 1 voltage G110 should be removed and inspected for a poor connection, for the presence of anti-corrosion paint behind the eyelet, or for a too long bolt installed.
