Bulletin No.: PIT6018C

PIT6018C IPC Display And Radio Blank, No Audio or Possible Update Failed Message On Display After a Discharged Battery Event

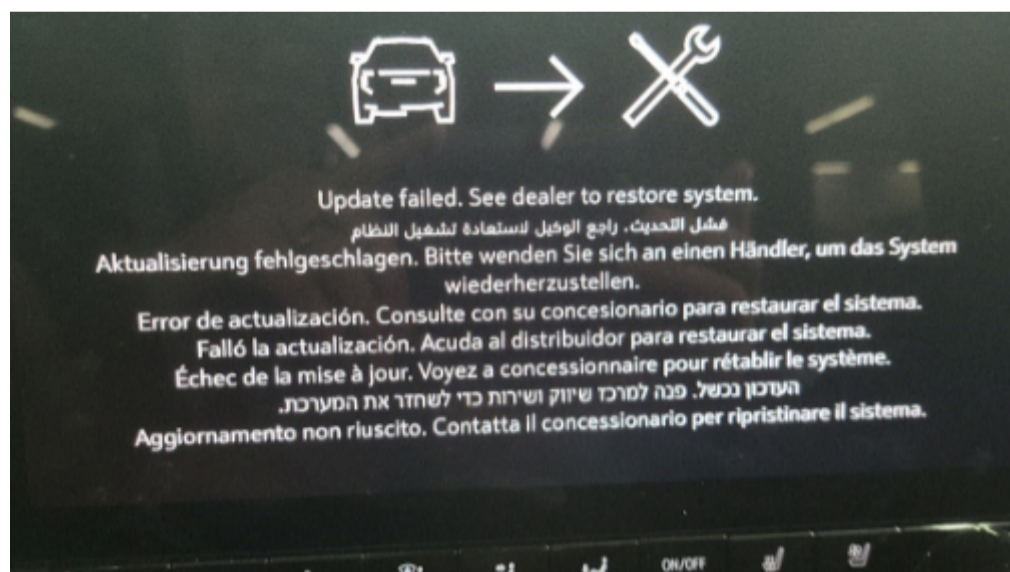
- 1.The screen will be black
 - i. Start at Section 1.
2. The screen will show the below update failed message asking to return the vehicle to the dealer (image)
 - i. Start at Section 2.

Section 2

Using SPS load an appropriate USB drive with the latest software.

After the USB drive is created by SPS, follow [PIT6047](#) **Radio USB Update Battery Ignore File** to create an additional file on the drive named gm_usb_ignore_battery.

Install the USB drive and shut the vehicle off.

While the vehicle is off and the USB drive is still connected, the radio will start recovering within 15-20 minutes.
