# Preliminary Information

## PIT6018D IPC Display And Radio Blank, No Audio or Possible Update Failed Message On Display After a Discharged Battery Event

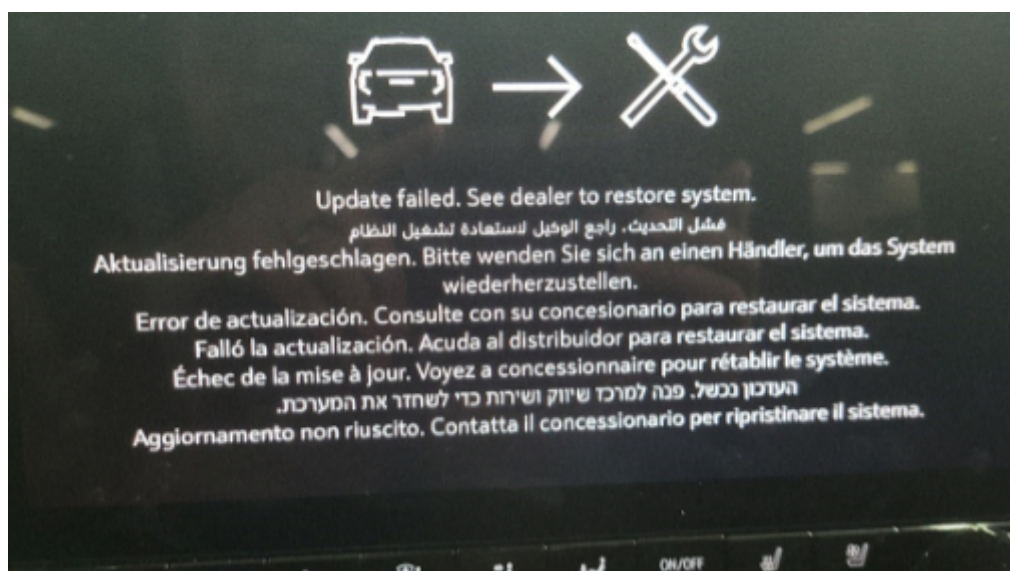
- 1.The screen will be black
  - i. Start at Section 1.
2. The screen will show the below update failed message asking to return the vehicle to the dealer (image)
  - i. Start at Section 2.

## Section 2

Using SPS load an appropriate USB drive with the latest software.

After the USB drive is created by SPS, follow [PIT6047](#) **Radio USB Update Battery Ignore File** to create an additional file on the drive named gm\_usb\_ignore\_battery.

Install the USB drive and shut the vehicle off.

While the vehicle is off and the USB drive is still connected, the radio will start recovering within 15-20 minutes.
