Preliminary Information

PIT6018E IPC Display And Radio Blank, No Audio or Possible Update Failed Message On Display After a Discharged Battery Event

Product Investigation Review Required

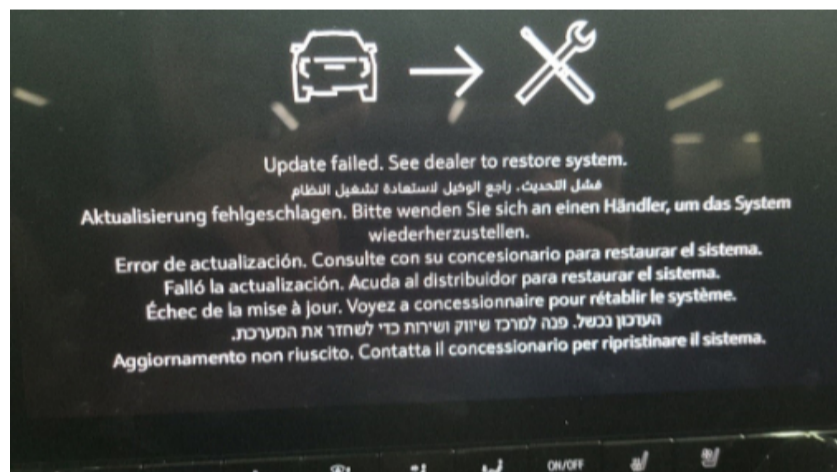
Involved Region or Country:	North America
Additional RPO(s):	Equipped with Infotainment System RPO IVD
Condition:	IPC Display And Radio Blank, No Audio. Possibly a Failed Update Message After a Discharged Battery Event
Cause:	Logic Lock Up Usually Due To Low Voltage Or A Failed Update.

1. The screen will be black
 - i. Start at Section 1.
2. The screen will show the below update failed message asking to return the vehicle to the dealer (image)
 - i. Start at Section 2.

Section 2

If function has returned perform a battery test, note results and attach to the repair order.

Using SPS load an appropriate USB drive with the latest software.

After the USB drive is created by SPS, follow [PIT6047 Radio USB Update Battery Ignore File](#) to create an additional file on the drive named gm_usb_ignore_battery.

Install the USB drive and shut the vehicle off.

While the vehicle is off and the USB drive is still connected, the radio will start recovering within 15-20 minutes.
