## PIC6493A Diagnostic Tip - Steering Wheel Contacting Column Covers

Brand:	Model:	Model Years:	VIN:		Engine:	Transmissions:
			from	to		
Cadillac	Lyriq	2023 - 2024	All	All	All	All

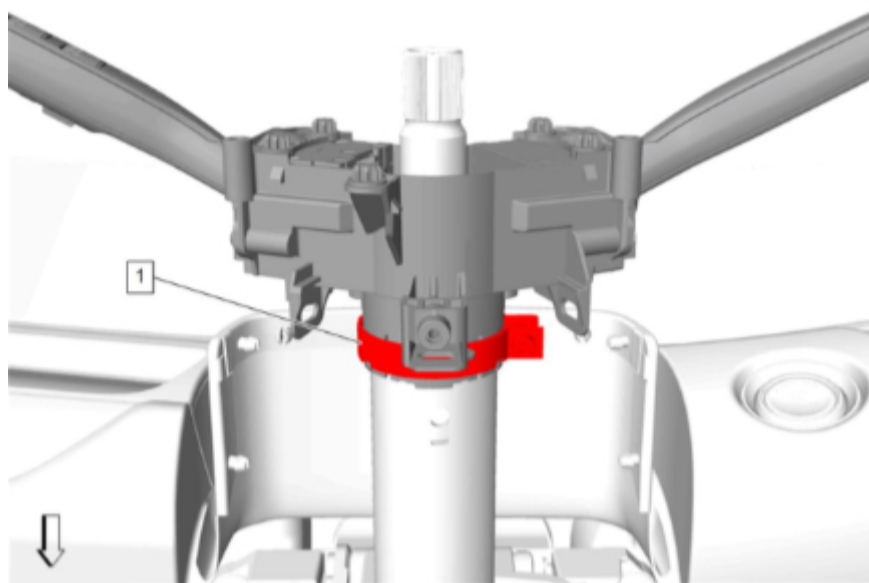
#### 1. Band Clamp

Involved Region or Country	North America
Condition	A customer may comment that the steering wheel is contacting the steering column covers causing a rub or scrape noise.
Cause	Possible turn signal switch bracket not correctly installed to the steering column.

Remove the steering column covers and inspect for the turn signal switch bracket to be correctly installed. Ensure the tabs on the turn signal switch bracket are fully engaged.

If it is found that the turn signal switch bracket is sitting too high on the column and the tabs are not engaged, loosen the bolt in the turn signal switch bracket band clamp and adjust the bracket to the correct position.

**Note: Do NOT remove the bolt in the turn signal switch bracket band clamp. The turn signal switch bracket will need to be replaced if the bolt from the turn signal switch bracket band clamp is fully removed.**
