Bulletin No.: PIT6018F

PIT6018F IPC Display And Radio Blank, No Audio or Possible Update Failed Message On Display After a Discharged Battery Event

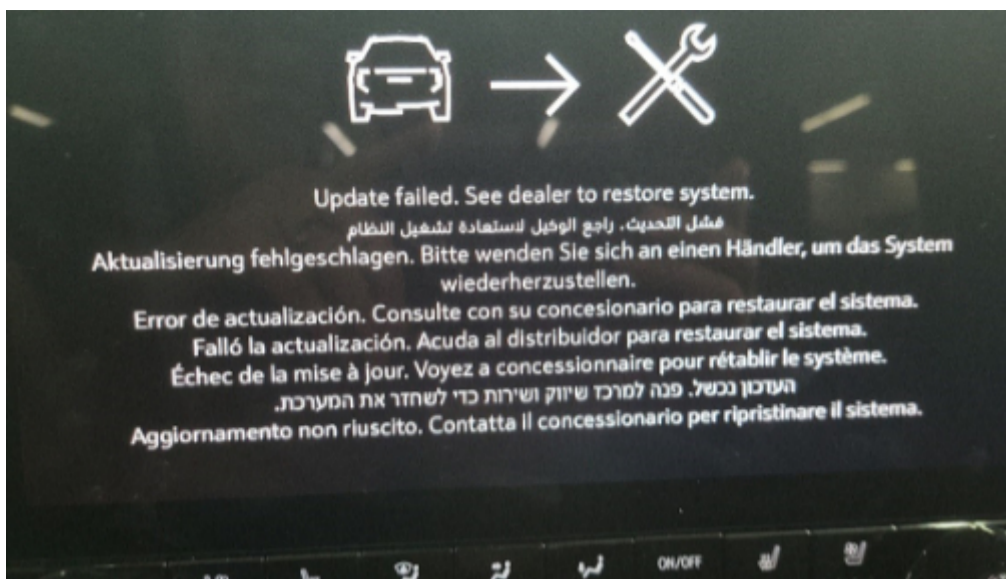
- 1.The screen will be black
 - i. Start at Section 1.
2. The screen will show the below update failed message asking to return the vehicle to the dealer (image)
 - i. Start at Section 2.

Section 2

Using SPS load an appropriate USB drive with the latest software.

After the USB drive is created by SPS, follow [PIT6047 Radio USB Update Battery Ignore File](#) to create an additional file on the drive named gm_usb_ignore_battery.

Install the USB drive and shut the vehicle off.

While the vehicle is off and the USB drive is still connected, the radio will start recovering within 15-20 minutes.
