Preliminary Information

PIT5985B Diagnostic Tip: No Start/ Ignition Will Not Turn ON/ No Power Due To A CAN bus 2 Issue/Lightning Strike/ Failed Over The Air Update

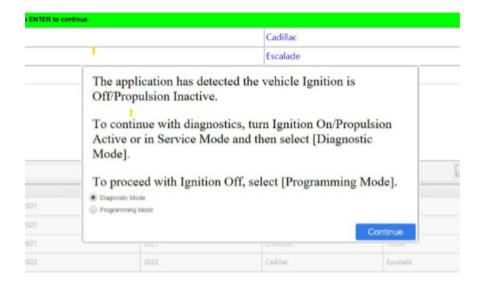
1) Dealership technicians will notice that they are unable to access GDS data to review DTC's or check the network communication status. They may experience the following pop up box, shown below, and will be unable to get past this screen. You will need to keep hitting the continue button 5-6 times and then it will allow you to get past this screen and then it will be possible to go into vehicle diagnostics to check DTC's and CAN bus status.

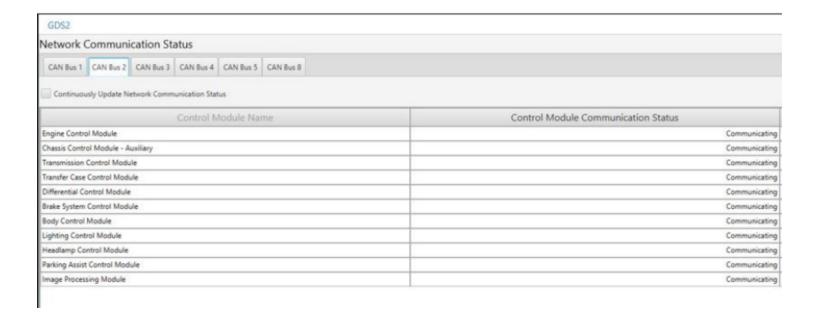
Go through each CAN bus tab (CAN bus 1 -8) and note/document the communication status of each module. When switching from tab to tab you may want to wait 25-30 seconds to see if modules show up. The picture below shows an example of CAN bus 2 status.

Diagnosis and repair any modules that are not communicating. If a module fails to communicate due to a failed OTA, first try to recover the module by reprogramming the module using SPS. Then clear all DTC's and recheck for concern.

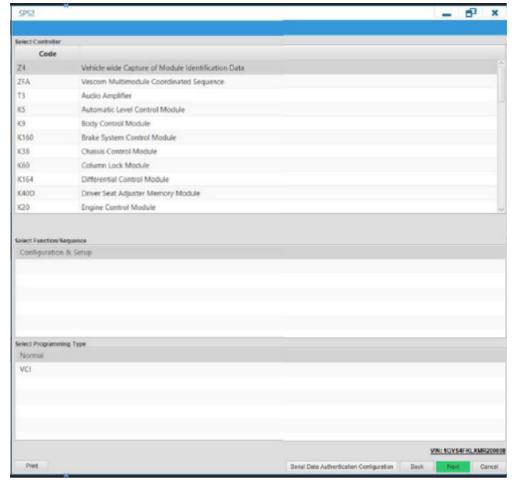
3) If after all modules are communicating and you continue to have issues or current DTC: U1962, then perform a Serial Data Authentication Configuration (SDAC), which is located on the SPS controller screen in the SPS, shown below. This will have to be completed so each module recognizes each other on their respective data buses.

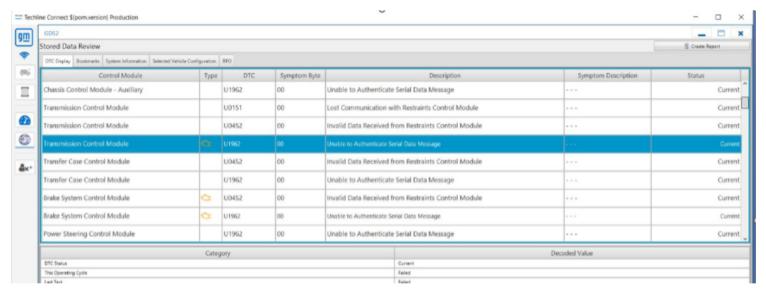
5) If the SDAC passes and a labor code is generated, make sure to clear all the U codes that are current or the vehicle still may not start.
