Preliminary Information

PIT6018G IPC Display And Radio Blank, No Audio or Possible Update Failed Message On Display After a Discharged Battery Event

Models

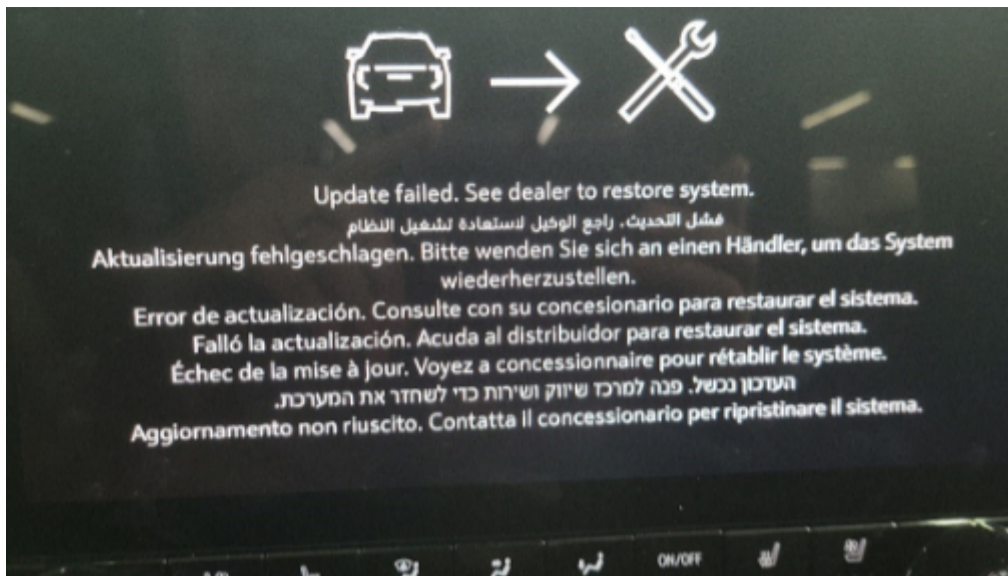
- 1.The screen will be black
 - i. Start at Section 1.
2. The screen will show the below update failed message asking to return the vehicle to the dealer (image)
 - i. Start at Section 2.

Section 2

Using SPS load an appropriate USB drive with the latest software.

After the USB drive is created by SPS, follow [PIT6047 Radio USB Update Battery Ignore File](#) to create an additional file on the drive named gm_usb_ignore_battery.

Install the USB drive and shut the vehicle off.

While the vehicle is off and the USB drive is still connected, the radio will start recovering within 15-20 minutes.
