**Volvo Car USA LLC****Technical Journal**

Technical Journal Title		Ref. No.	
Wireless Phone Charger (WPC) - no/unstable charging		TJ 36693.2.0	
Issuer (Dept.)		Issue Date	Status Date
Technical Service		8/14/23	8/22/23
Car Market	Partner	Function Group	
United States and Canada	3 US 7510 Volvo Car USA	3942	
Function Description		Page	
Mobile telephone		Page 1 of 4

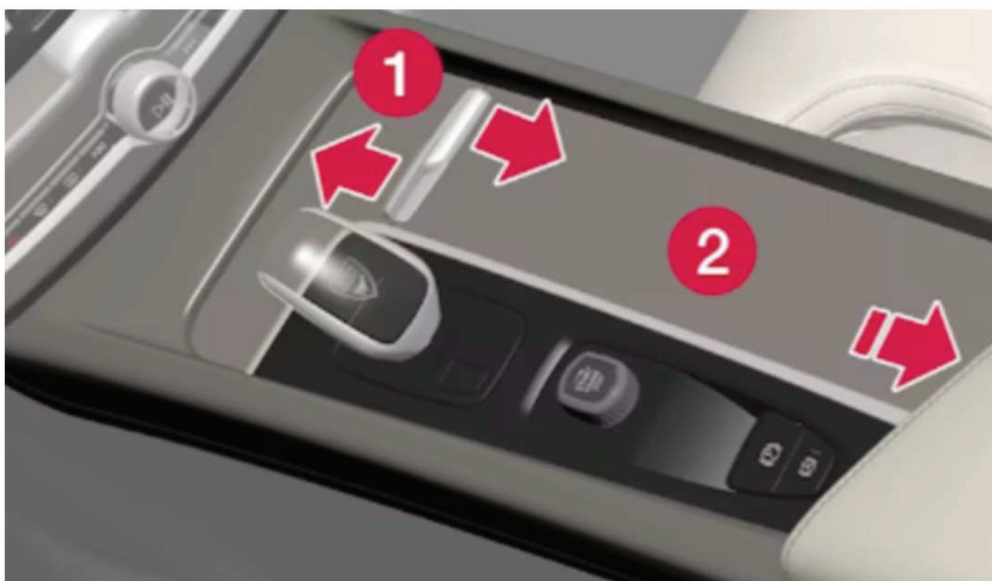
TJ 36693

- When performing PDS SWDL on MY24 cars with a WPC, hardware part no. 32359823, it is crucial that no phone or other external metallic object is placed on top of, or near (up to 60mm), the WPC. The car radio must also be off. For SPA cars, open the blinds/hatches in the tunnel console (see attachment).
- If this was not followed during the PDS SWDL, then the WPC will be incorrectly calibrated, resulting in no charging or unstable charging performance. To solve this issue, recalibrate the WPC by performing the following sequence:

1. Make sure that the blind/hatch in the tunnel console is open and that there are no phones or other external metallic objects placed on top of, or near (up to 60mm), the WPC.
2. Download "WPC FIX".
