SIB 63 09 23
REAR INTERIOR LIGHTS ARE INOPERATIVE

2023-08-14

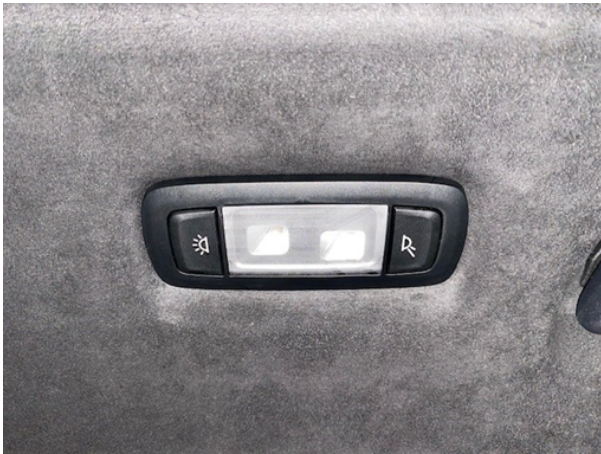
G05, G06, and G07 second row interior light

The interior lights in the rear of the passenger area do not work.

Unfavorable actuation of the interior light.

Perform a 10-minute battery reset.

1. Perform a 10-minute battery reset following the repair instructions listed in ISTA/AIR (61 20 900) and check the functionality of the interior lights.
2. If the interior light does not work after the battery reset, continue with your diagnosis.
