SIB 65 01 22

## KNEE AIR BAG CCM G01 VARIANT WIRE HARNESS REPAIR

This Service Information Bulletin (Revision 5) replaces SI B65 01 22 **dated November 2022**.

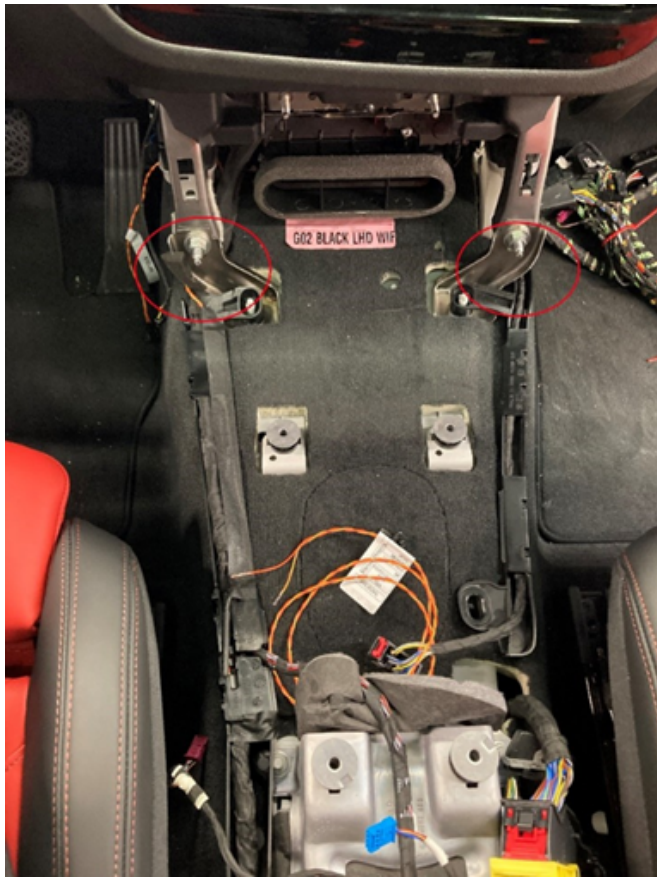
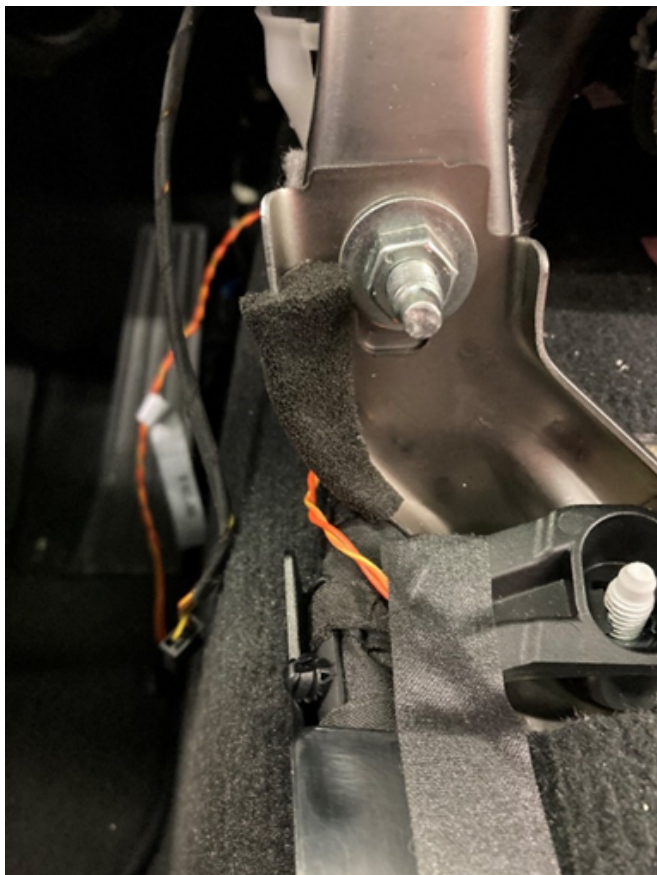
Over time, the wiring harness going to the knee air bag(s) can rub against the metal support tubes for the instrument panel, chafing and damaging the wiring.

5- Apply felt tape to the locations pictured.

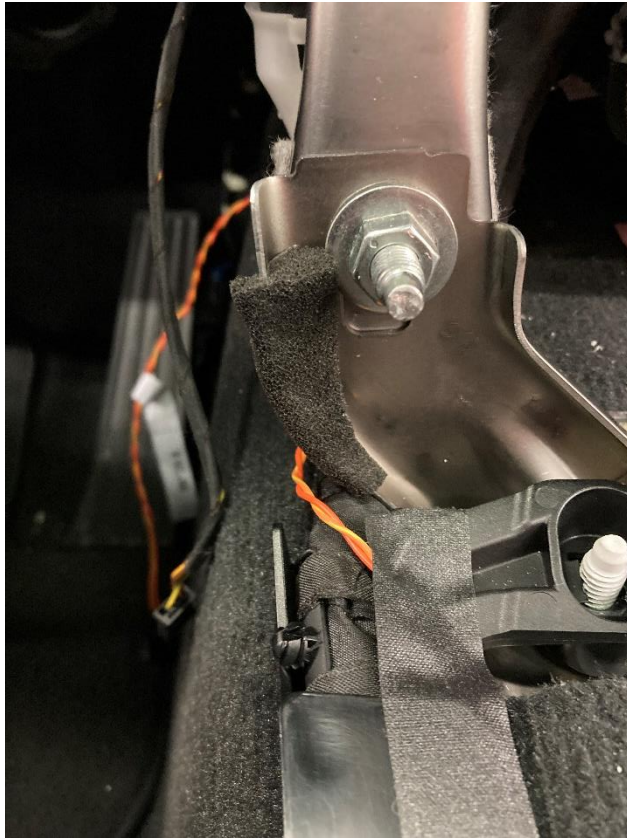
The wiring harness going to the knee air bag(s) may be rubbing against the support tube of the instrument panel.

5- Apply felt tape to the locations pictured.

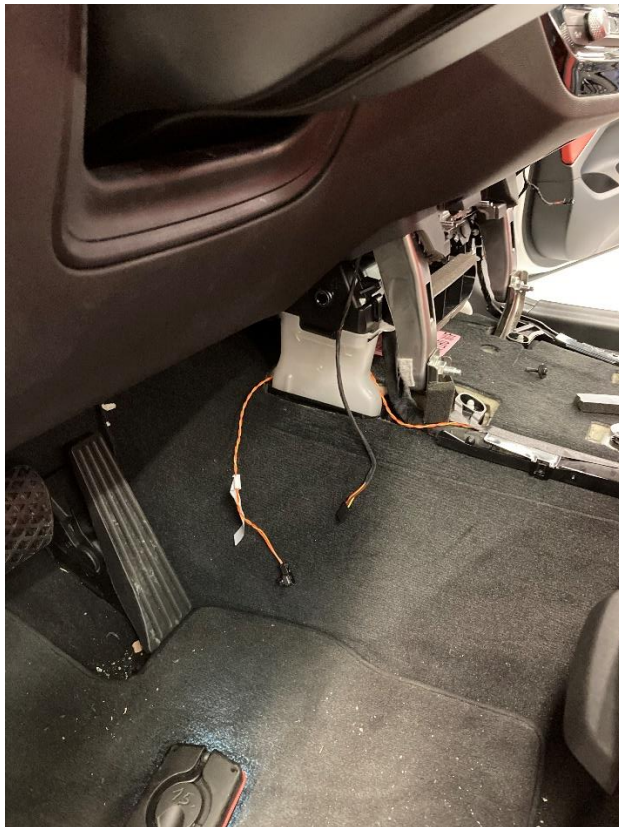
6- The knee air bag wiring should be protected from chafing at the dash support bracket.

Glue the felt generously onto the support tube or to the corresponding edge.

(Felt tape part number **54 34 7 248 700**).

Important: The felt must be glued around the edge!
