SIB 66 12 23

2023-08-24

DELIVERY STOP: HANDS-OFF OPTION MISSING

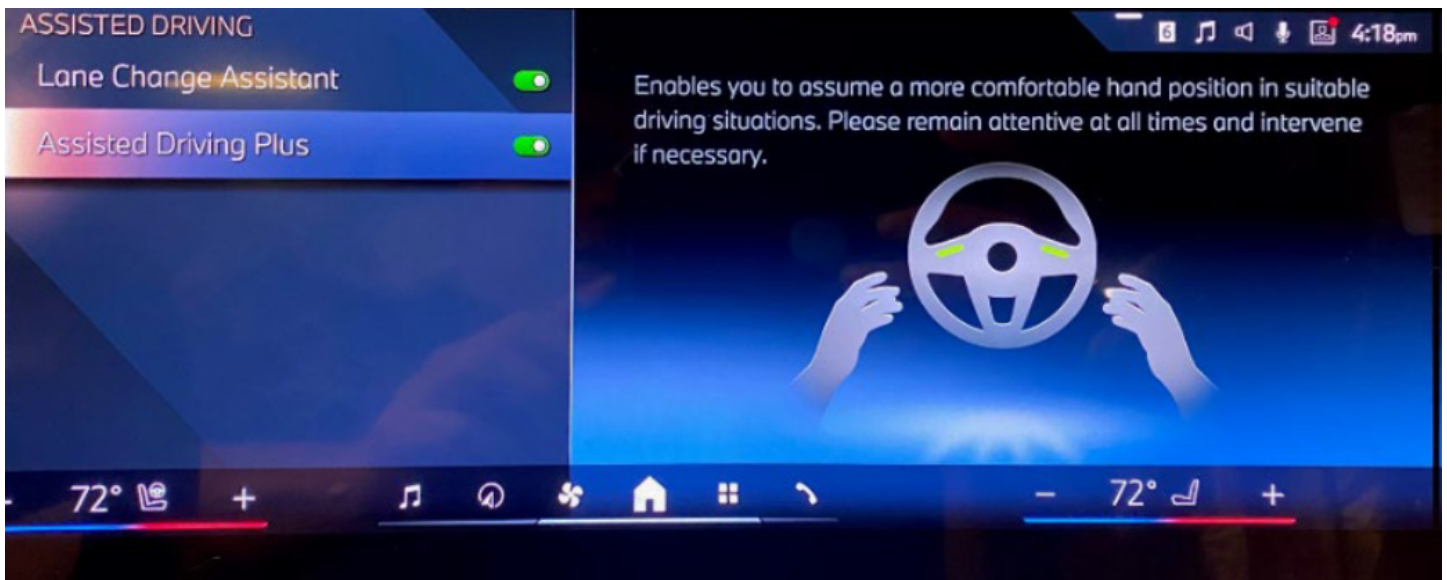
Function successfully activated-

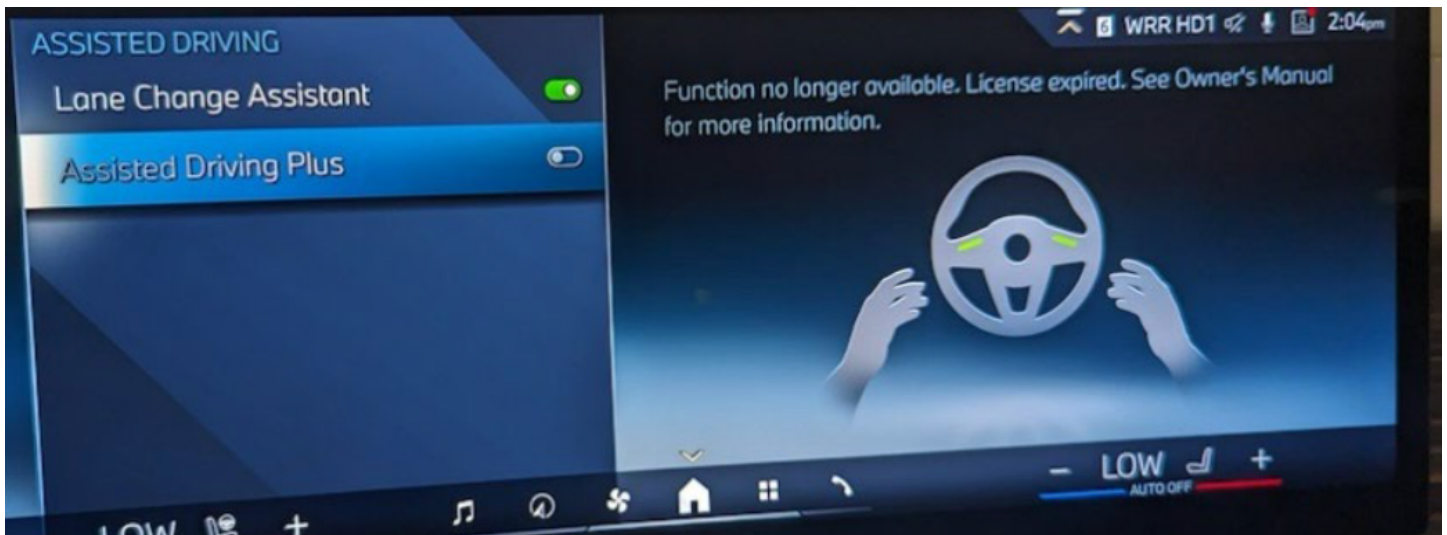
Function not successfully activated-

Important note: If the vehicle's I-level is above ...23-07-535 and still doesn't have 5AX activated, follow the below procedure.

Manually select MPAD and MPAD2 for programming and encoding under the follow tabs.

- Vehicle management
- Software update
- Advanced

Program the vehicle and test system operation.
