SIM 54 01 23

PANORAMIC ROOF SUNBLIND DOES NOT CLOSE/JAMS

E-Series	Model Description
F54	MINI Clubman
F55	MINI Hardtop 4 Door
F56	MINI Hardtop 2 Door
F60	MINI Countryman

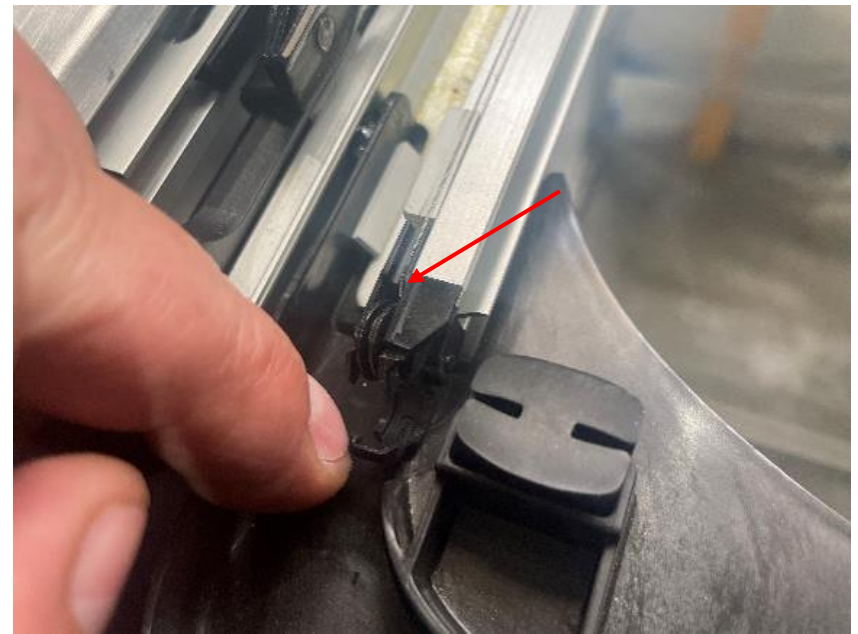
SITUATION 1

- The cable is located between the deflecting element and the housing.

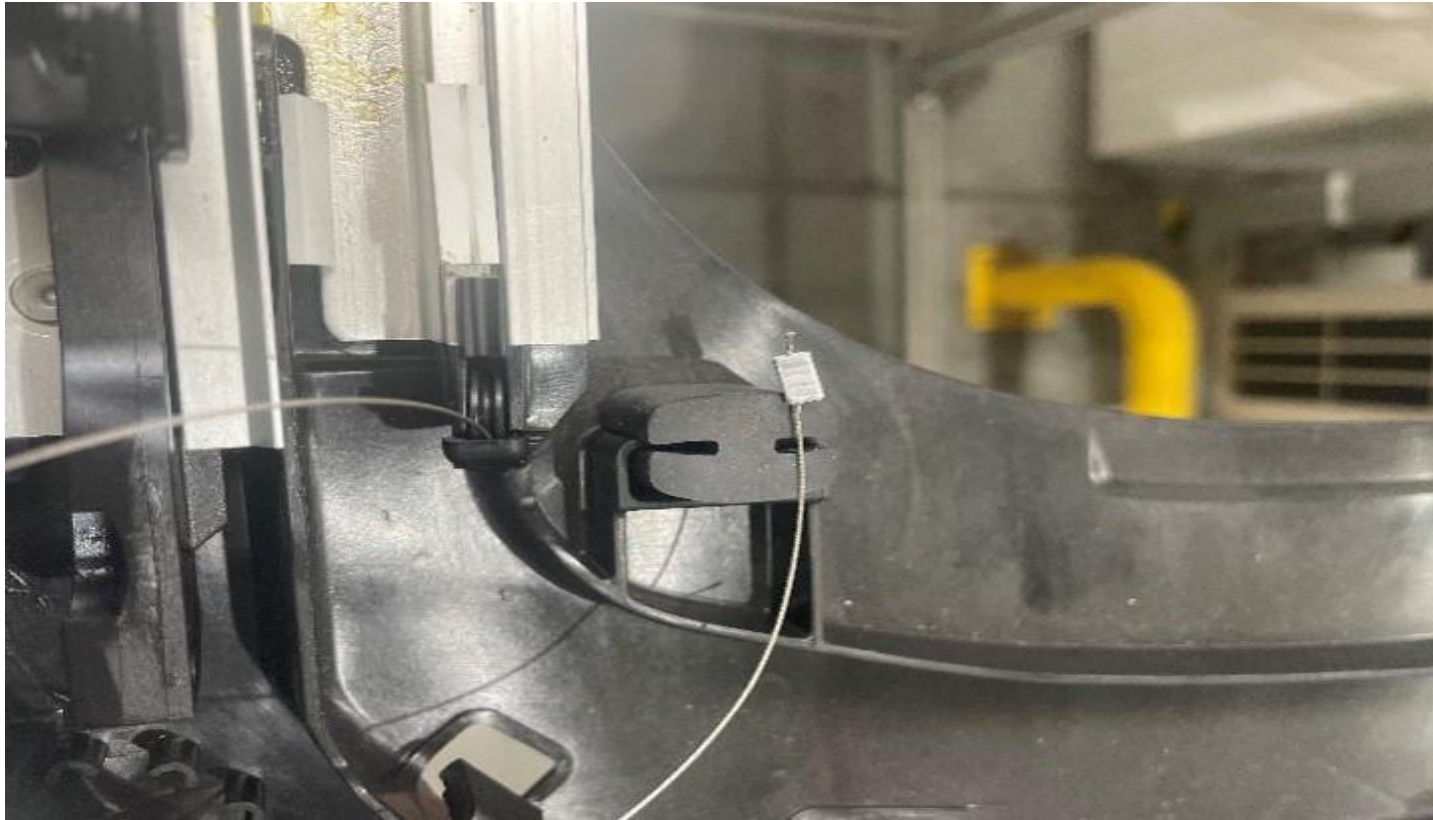
SITUATION 2

- Cable end piece unhooked from the roller blind.
