TDT 2023-03 AND TDT 2023-04 BUG NOTIFICATION

TOL NOTICE (US&CA) – August 4, 2023

TOL Ref. #24856- SVC

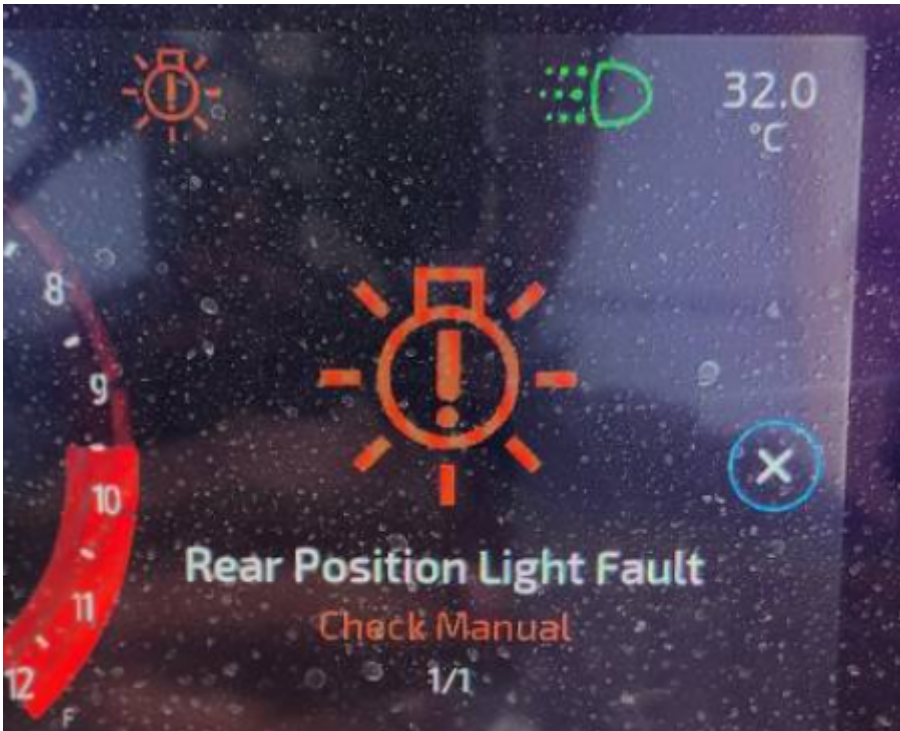
A “Rear Position Light Fault” error message can falsely be displayed on the instruments of New Tiger 1200 models (PM1, PR1, PS1, PX1, PY1) using either the TDT 2023-03 or TDT 2023-04 CCU calibration.

We can confirm that this is an **incorrect** warning message and that the function of the rear light is unaffected. A revised CCU calibration is being developed and will be released with a new TDT update ASAP.

To lessen the impact to customers, we advise dealers **do not** download the latest CCU calibration from TDT 2023-03 or TDT 2023-04 to New Tiger 1200 models (PM1, PR1, PS1, PX1, PY1) until further notice.
