Service Update

N232403190 Intermittent Electrical Failures – Loose Grounds

Release Date: September 2023

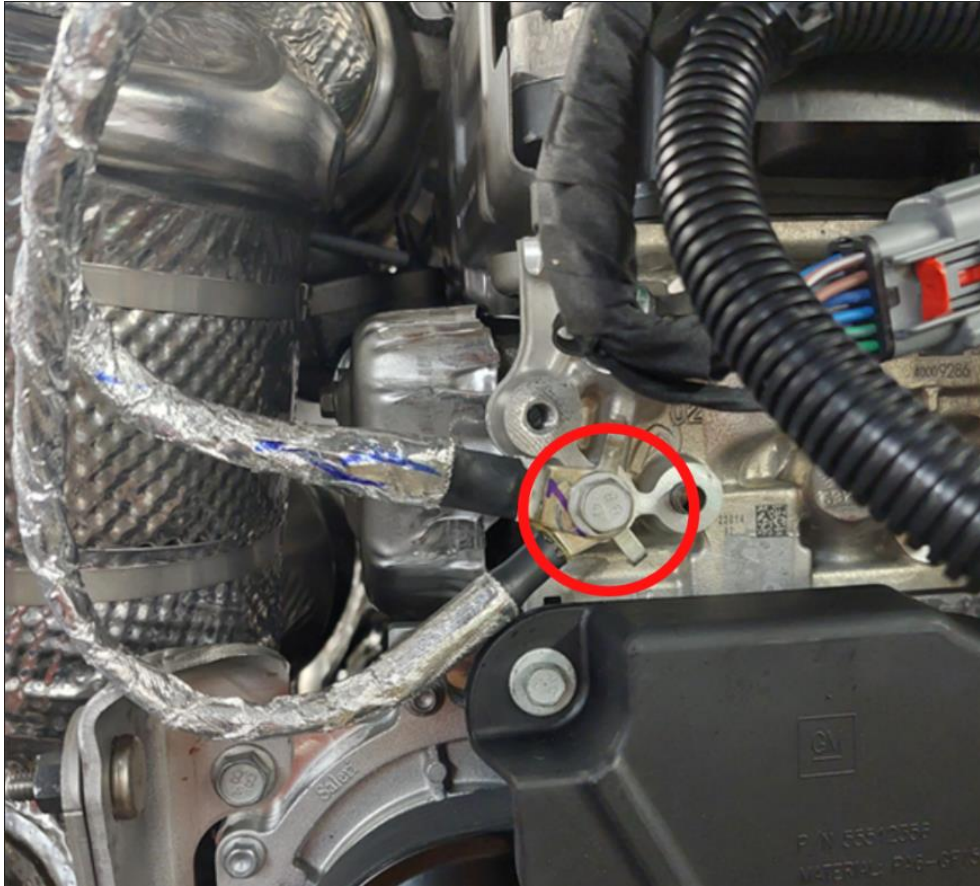
6431284

1. Inspect the bolt securing grounds G176A / G177B on the front of the cylinder head to be sure the bolt is properly torqued and is not cross-threaded.
 - If the bolt is not cross-threaded and has good clamp load so the grounds are firmly fastened to the head, no further action is required.
 - If the bolt is visibly cross-threaded, or the grounds are not secured firmly to the head, proceed to step 2.
2. Remove and discard the bolt.

CAUTION: It is critical to ensure the tap is going into the bolt hole completely straight in both the vertical and horizontal plane.
