GROUP	MODEL
ELE	2023MY Niro P/HEV, EV (SG2 P/HEV, EV) EV6 (CV)
NUMBER	DATE
300 (Rev 1, 09/18/2023)	August 2023

TECHNICAL SERVICE BULLETIN

SERVICE ACTION: MOOD LAMP OPERATION LOGIC IMPROVEMENT (SA536)

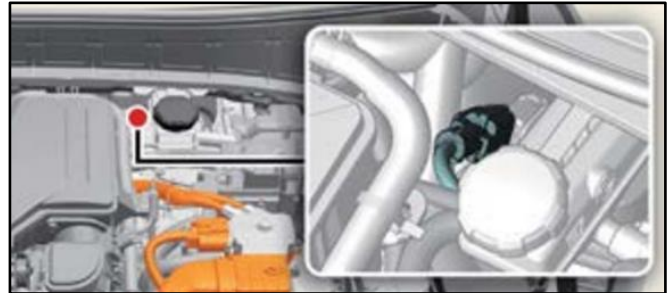
If the mood lamp is currently inoperative in Niro HEV (SG2 HEV) vehicles, disconnect the 12V auxiliary battery connector located near the brake fluid reservoir for ten (10) seconds, then reconnect the 12V auxiliary battery connector and proceed to software logic installation.
