**RAPID UPDATE**

# Rapid Update 655 MC20 – AC pipe connection check

DATE: AUGUST 2 2023

Certain Maserati MC20 and MC20 Cielo(M240) MY22 MY23 listed in MODISCS+ are involved in a Rapid Update to check one of the air conditioning (AC) pipe connection nuts.

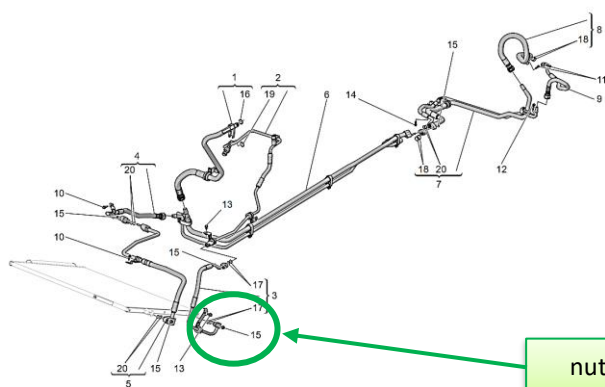
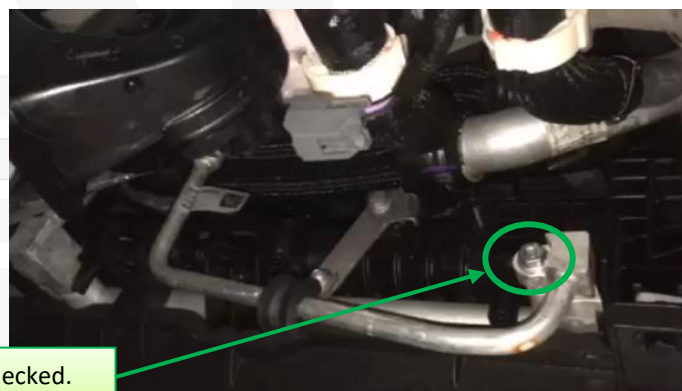
This action is necessary because, in a single case found at the plant, only one fastener has been discovered with lower tightening. Consequently, this could lead to a loss of efficiency and performance of the system, which does not meet the required standards. Although the expected failure rate is close to 0%, we are requesting to check the pipe connection nut to ensure it is properly torqued.

4. Once the aerodynamic panel has been removed, locate the AC pipe connection to be checked, as indicated in the picture below.
  - **POS. 15 NUT - table 08.40 - 3 A/C UNIT: ENGINE COMPARTMENT DEVICES**

nut to be checked.

5. **Use a torque wrench:** Torque the nut to **9Nm (nine)**.

| 6. Screw connection | |
|---|---|
| 7. Tightening nut | 8. 9 Nm (6.6 ft-lb) |

9. **ONLY IF the nut was not tightened to spec:** Check AC system operation. proceed with recharging the climate control system ONLY if needed. Per the workshop manual:
