# Rapid Update 656

## Grecale – Air suspension system check

DATE: AUGUST 2 2023

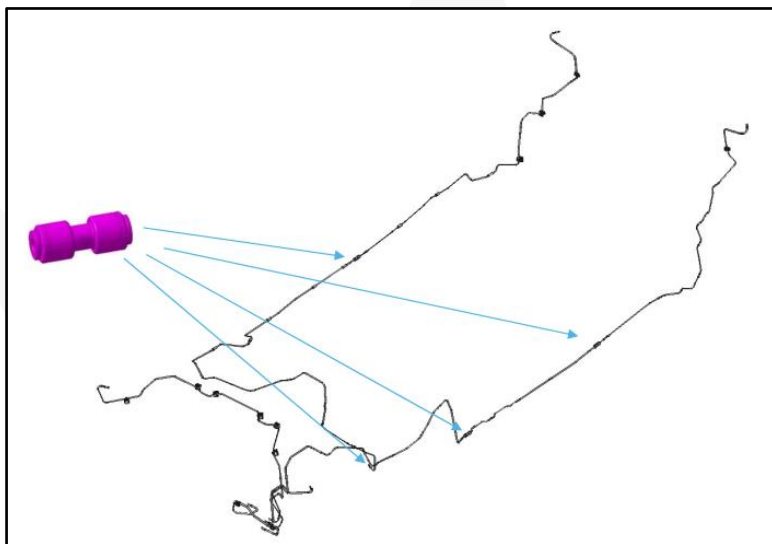
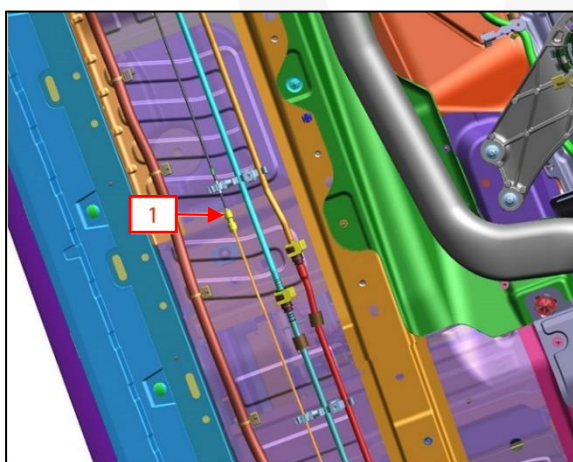
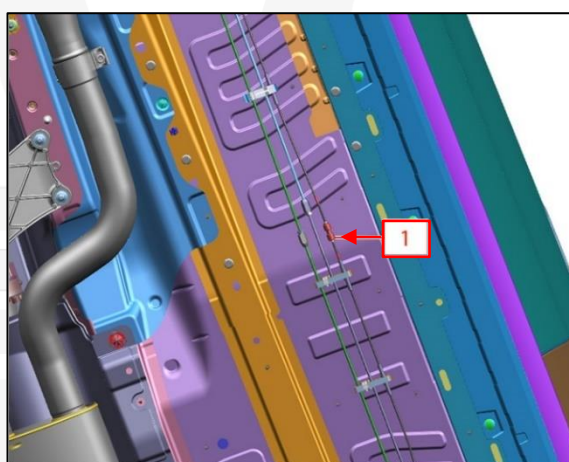
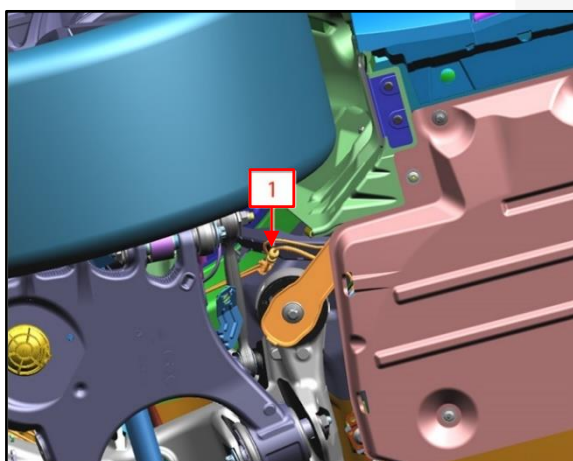
If any anomaly is detected in the procedure for operating the air springs, it is necessary to check all 4 air pipe couplings in which the circuit is divided and the connections on the air springs.

1. Remove the underbody guards according to the procedures in the workshop manual:
  - **9.14.044.0**      **CENTRAL LH UNDERBODY GUARD**      **00**
  - **9.14.043.0**      **CENTRAL RH UNDERBODY GUARD**      **00**
  - **9.14.097.0**      **REAR CENTRAL RH UNDERBODY COVER**      **00**
2. Check for air leaks using a gas leak detector liquid (e.g., Snoop Leak Detector) or equivalent at the following points (1) as illustrated below.

**NOTE:** If an air leak is evident from any of the areas of the air pipe couplings, it is necessary to replace the two components of the sections (male end and female ends) following the workshop procedure.

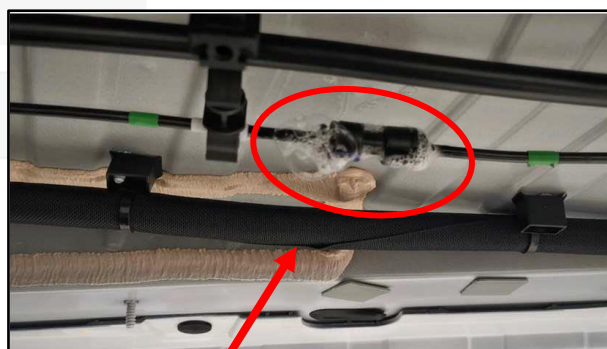
**Example:** of air leak at air pipe indicated by bubbles using a gas leak detector or equivalent
