MAS003715 RU 23-45

# Rapid Update 585 MC20 – Rear axle shaft replacement

**DATE:** AUGUST 3 2023

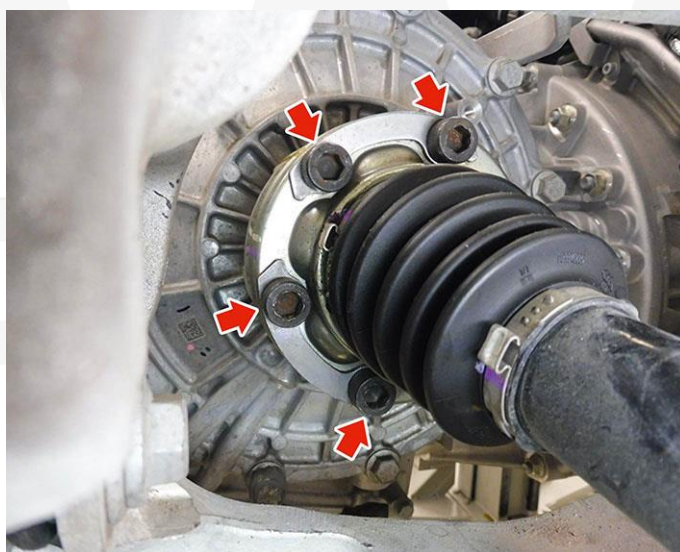
**NOTE:** during the disassembly procedure, if **broken screws** are found or the **threads** on the gearbox flange are **damaged** open a BOL report as "Support Request" for assistance.

5. **Use a Torque Wrench:** Follow the workshop manual instructions and tighten/torque ALL the screws.

Tightening torque of the axle shaft screws - 03.10.145	
<b>1. TIGHTENING TORQUE</b>	30N ·m (22.1 ft-lb)
<b>2. ANGLE</b>	90° (1.57 rads)
<b>3. CONTROL TORQUE</b>	45N ·m (33.2 ft-lb)
