MAS003745 RU 23-47

# Rapid Update 659 Granturismo – Brake pad connector Check

DATE: AUGUST 4 2023

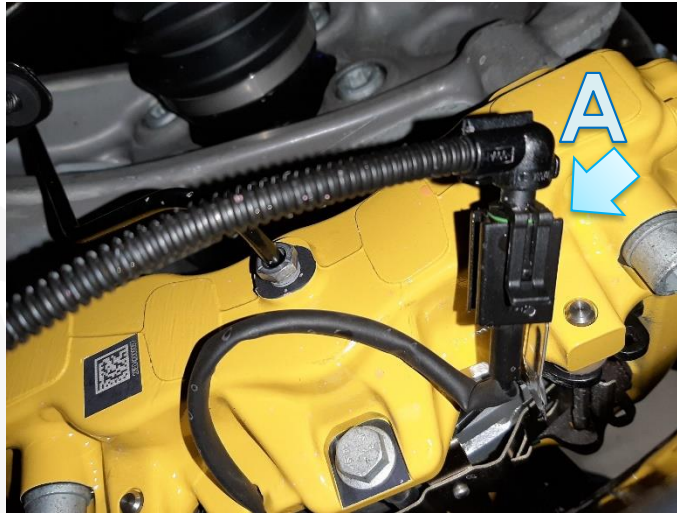
This action is necessary because, on a small number of vehicles, the brake pad wear sensor connector may not have been inserted correctly into its seat. This could lead to disconnection of the connector with the risk of cable wear. This potential concern is not affecting the braking system functionality.

1. Always check ModisCS+ to see if the vehicle is involved in this action and if it has not been previously performed.
2. Remove the front wheels following the procedure in the workshop manual.
  - **06.00.002 LH FRONT WHEEL RIM. Removal-Refitting**
3. Identify the pad wear sensor connector (A) on the caliper and push it all the way into its seat with your finger, checking that it is correctly inserted.

4. **Note:** If the connector has completely come out of its seat and shows signs of wear, it will be necessary to open a BOL as "SUPPORT REQUEST" and replace the pads.
5. Check on both sides of the vehicle.
6. Reassemble all the removed parts following the procedure in reverse order.
7. Procedure Complete.
