MAS003664 RU 23-36

# Rapid Update 649

## MC20 – Radiator pipe coolant leak

DATE: AUGUST 1 2023

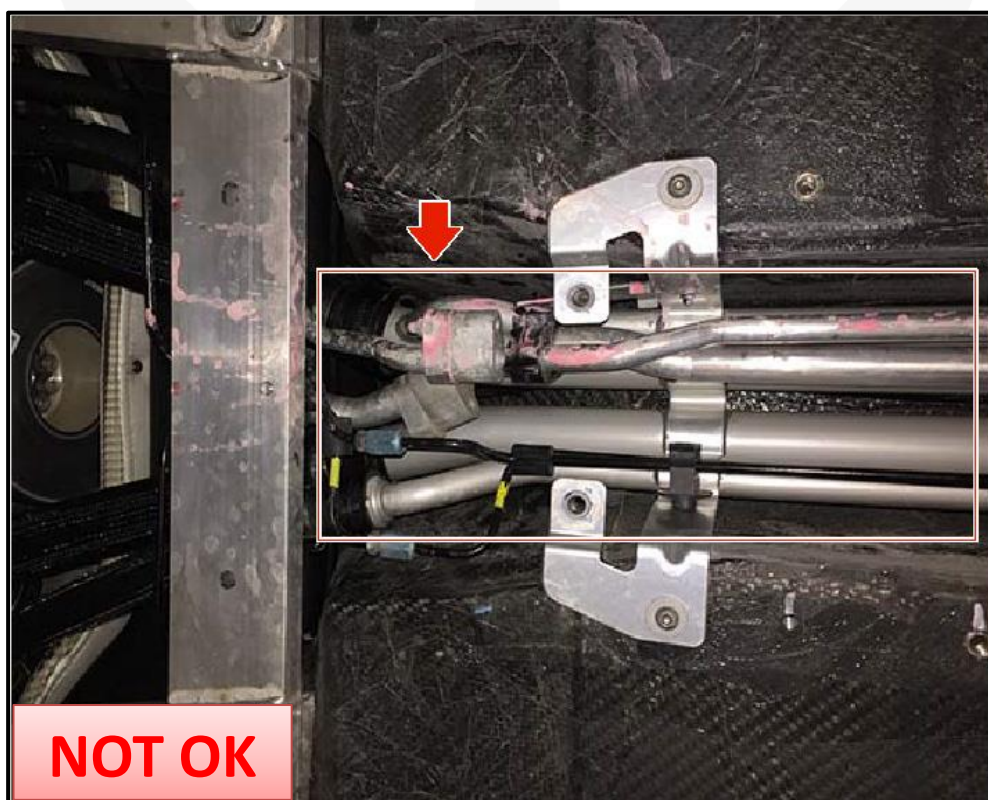
Example: Figure 1

1. Always check ModisCS+ to see if the vehicle is involved in this action and if it has not been previously performed.
2. If thread lock has been used, refer to the following workshop section for bolt cleaning:
  - **00.AB.065 - THREADED ELEMENTS CLEANING TABLE**
3. Before performing this operation, please follow the indicated procedure for interior protection: **00.AA.005 - INTERIOR VEHICLE PROTECTION**
4. Safely lift the vehicle in the air.
5. Remove the body aerodynamic cover.
  - **09.14.089 - BODY AERODYNAMIC COVER - Removal/refitting or replacement**
6. Remove the rear aerodynamic central cover.
  - **09.14.090 - REAR AERODYNAMIC CENTRAL COVER - Removal/refitting or replacement**
7. Visually inspect for possible coolant leaks. (See example figure. 1)

- **OK** ▶ **No leak found:** No further action needed. ▶ Reinstall all removed components. Operation complete.
- **NOT OK** ▶ **Leak found:** Coolant leaks are present (pink spot on the pipe and the under body). ▶ **Continue to Step 9.**

9. Perform the pipes replacement:

- **01.71.231 - REAR WATER PIPES - Removal/refitting or replacement**

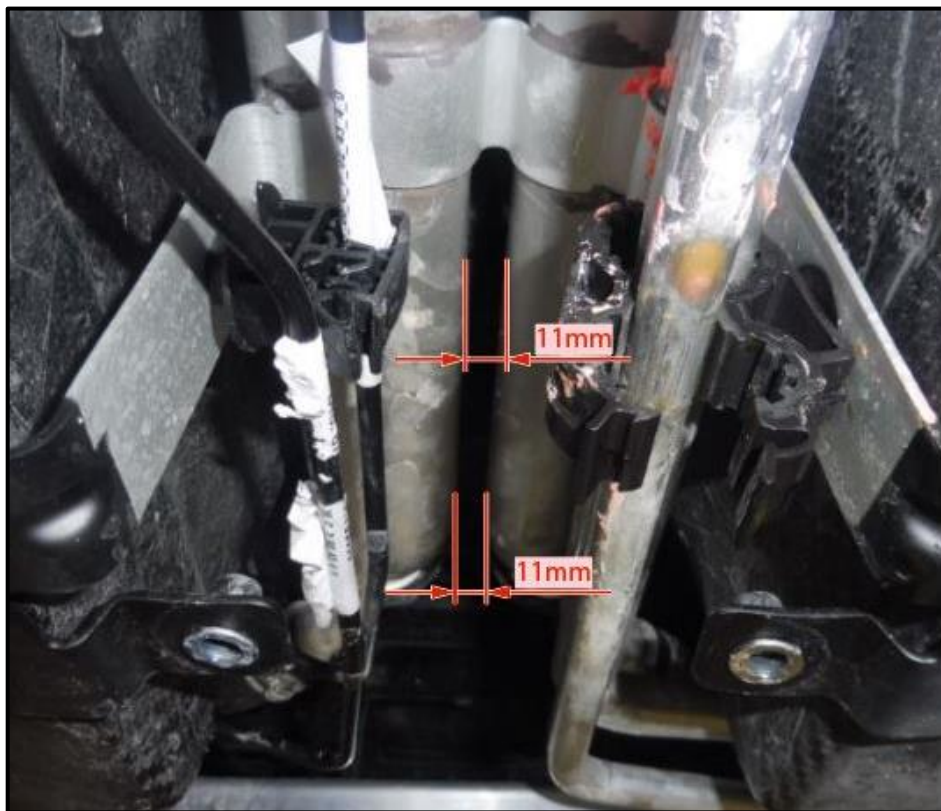
Figure 2

**NOTE:** For the pipes that did not pass inspection, there may be a deviation in spacing between the two from the bracket to the hose connection. The distance between the two pipes shown in figure 2 must be approximately the same (equally parallel around 11mm).
