MAS003712 RU 23-38

Rapid Update 653

Granturismo – front hood striker bolt check

DATE: AUGUST 1 2023

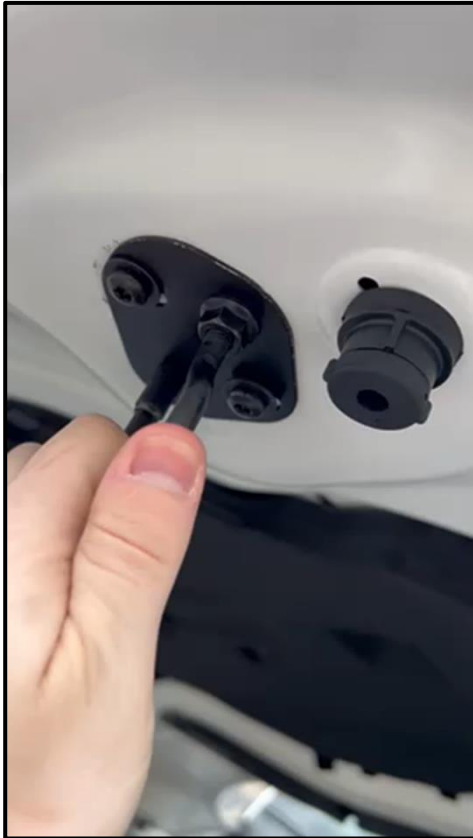
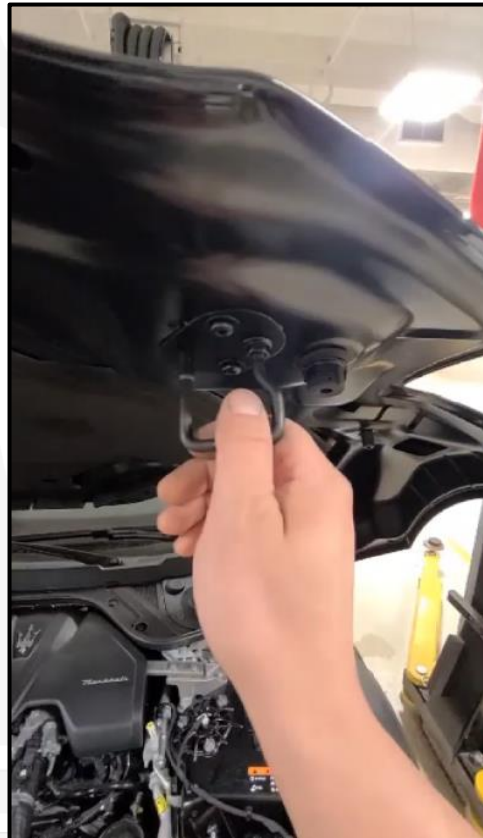
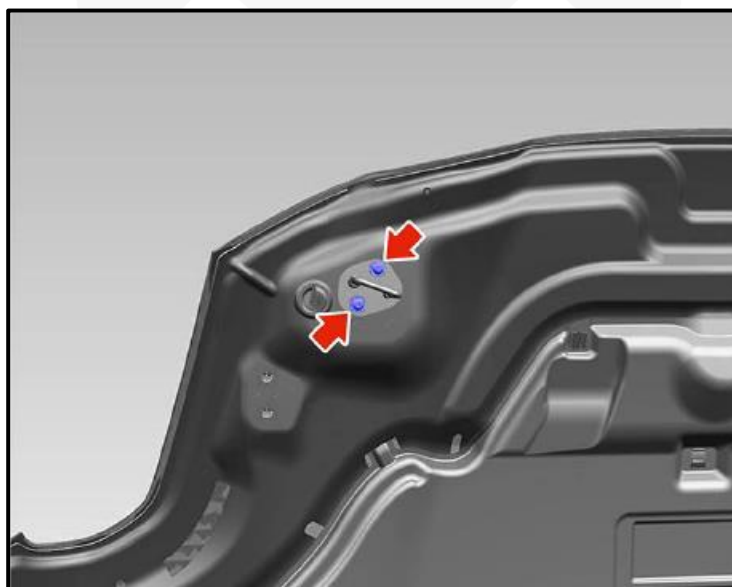
This action is necessary because, on a single case found at the Plant, only one fastener has been found with a lower torque per the data. This concern does not lead to a potential unexpected hood opening and no parts were found disconnected. The only potential consequence is related to some rattling noises due to the vibration. The procedure consists of a simple check with a torque wrench and possible torque tightening of the incorrect tightening. The expectation, however, it's not to find any vehicle with this concern.

1. Always check ModisCS+ to see if the vehicle is involved in this action and if it has not been previously performed.
2. Open the front hood and locate both hood strikers, located on both the front right and front left sides of the front hood.
3. **Use a torque wrench** to torque the two fasteners on each striker to **8 (eight) Nm**.

TORQUE SPECIFICATIONS	
Right Front Striker Fasteners	8 Nm (5.9 ft-lb)
Left Front Striker Fasteners	8 Nm (5.9 ft-lb)

4. Carry out the procedure for all 4 Hood striker fasteners.
5. The procedure is completed.
