SIB 12 04 23

SERVICE ACTION: REPLACE CHASSIS GROUND CABLE NUT

G01 (X3 Sports Activity Vehicle)	G02 (X4 Sports Activity Coupe)
----------------------------------	--------------------------------

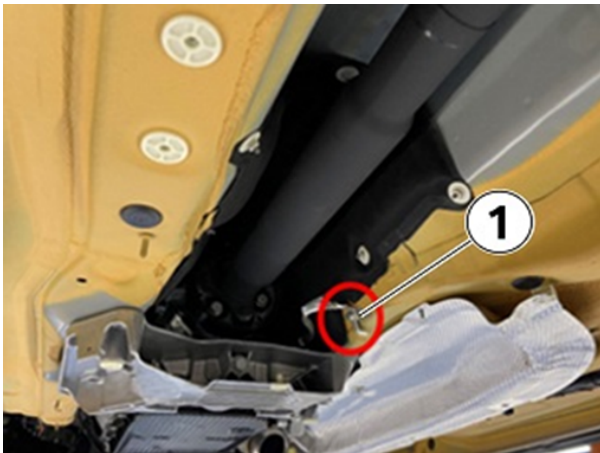
### Vehicles with sDrive:

An unapproved nut was used for the ground point for the chassis ground. Corrosion can occur on the ground nut over the life of the vehicle. As a result, malfunctions could occur, which are displayed in the vehicle by a check control message. In rare cases, local overheating at that ground point is a possibility.

Remove the exhaust to access the transmission tunnel. Replace ground nut (1) at this location on the transmission tunnel.
