SIB 41 07 22

## CRACKING SOUND FROM THE TOP OF B-PILLAR

This Service Information Bulletin (Revision 02) replaces SI B41 07 22 **dated March 2023**.

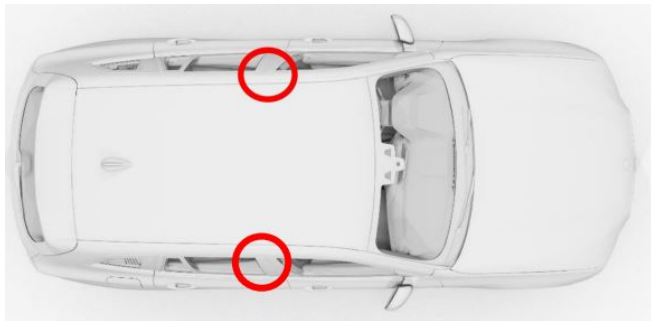
While driving the vehicle on normal roads at 10mph and above, a "cracking" sound from the top of the B-pillar(s) is heard.

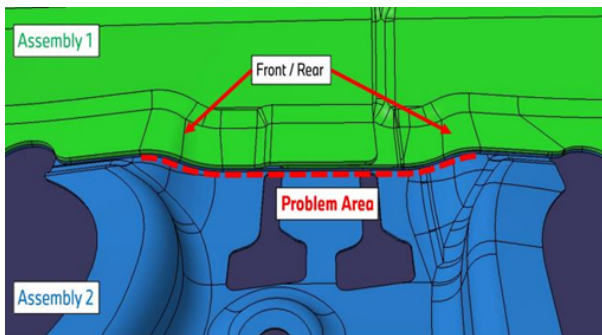
Movement of the sheet metal layers at the B-pillar(s).

Drill a 6-8 mm hole through the first three sheet metal layers.
