SIB 54 01 23

2023-08-04

## WATER INGRESS FROM THE PANORAMIC GLASS SUNROOF

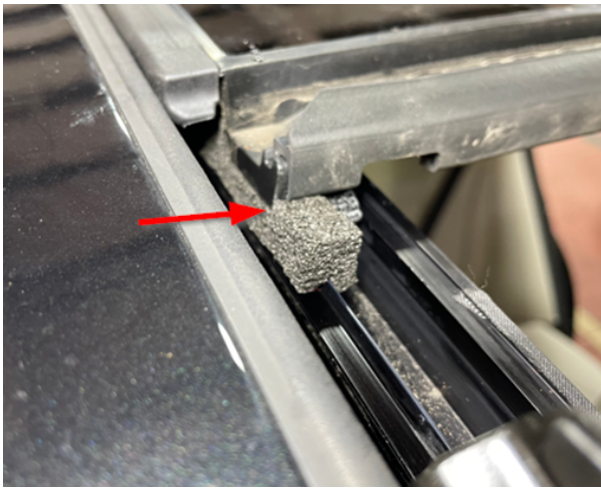
The photo shows the correct mounting orientation of the Dyko foam.

- The outer edge of the foam must be under the lip of the rear glass drip tray
- The rear glass needs to be correctly adjusted so that the water drains into the outer channel of the sunroof

**Note: Vehicles with production date before March 26, 2020 use a Dyko foam seal.**

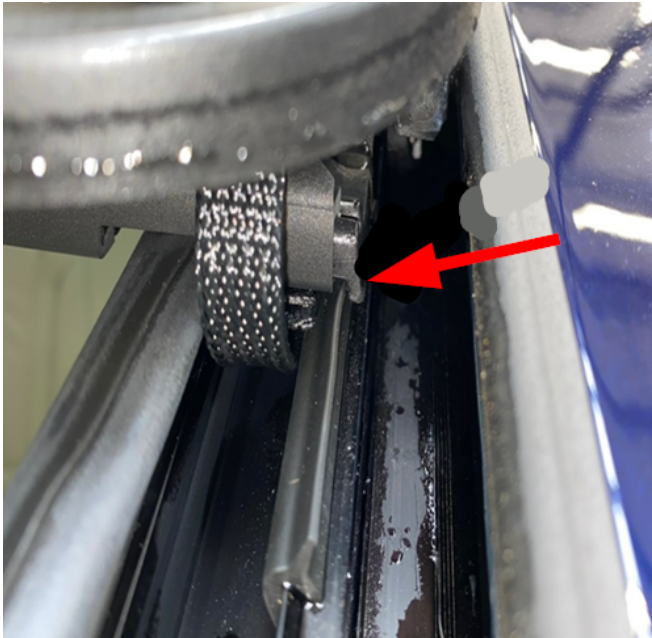
The photo shows the correct mounting orientation of the Dyko rubber seal.

- The outer edge of the rubber seal must be under the lip of the rear glass drip tray
- The rear glass needs to be correctly adjusted so that the water drains into the outer channel of the sunroof

**Note: Vehicles with production date after March 26, 2021 use a Dyko rubber seal.**

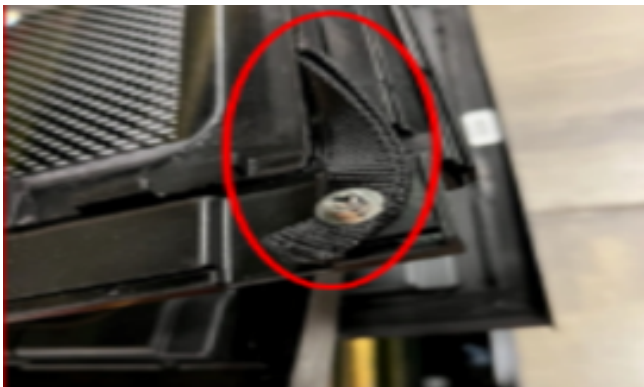
The photo shows the tether twisted. Incorrect position of tether.

**Note: The tether is screwed to the rear glass panel.**

1. Remove the front glass panel following the repair instructions listed in ISTA/AIR (54 13 240).
2. Inspect the Dyko foam/rubber seal for proper installation. Adjust/replace the Dyko seal if necessary.
3. Inspect the seating position of the rear glass panel/drip tray. Adjust the rear glass panel if necessary.
4. Inspect the position of the tether. Adjust the position of the tether if necessary. The rear glass needs to be removed.

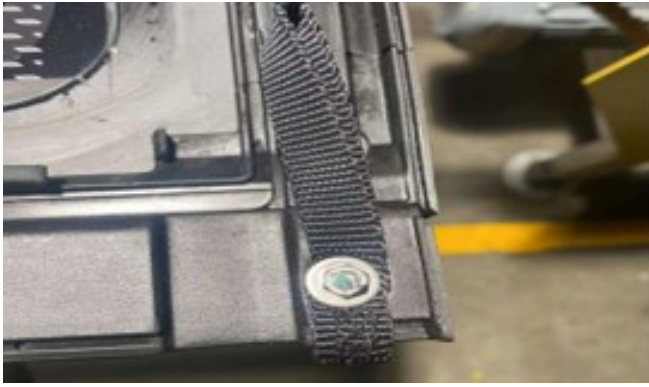
The photo shows the tether is in its correct position.
