SIB 54 03 22

BUZZING SOUND HEARD IN THE SKY LOUNGE ROOF

| E-Series | Model Description | Affected Option Code |
|---|---|---|
| I20 | iX Sports Activity Vehicle | 407 Panoramic Eclipsing Roof |

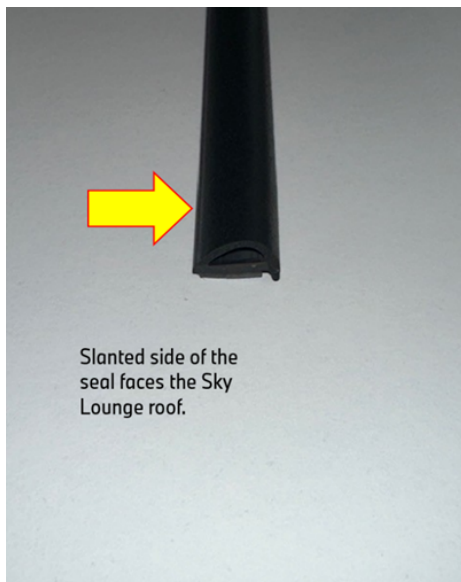
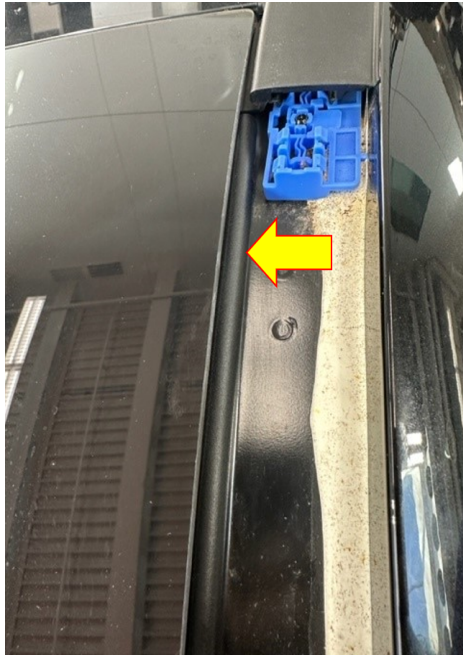
At high outside temperatures, the inner roof trim seal will become soft. Therefore, causing the inner roof trim seal to flap against the Sky lounge roof while at highway speeds.

3. The slanted side of the seal faces the Sky Lounge roof.

4. Attach the seal to the Sky Lounge roof frame.
