SIB 61 02 20

2023-08-17

KNOCKING NOISE FROM WASHER FLUID RESERVOIR

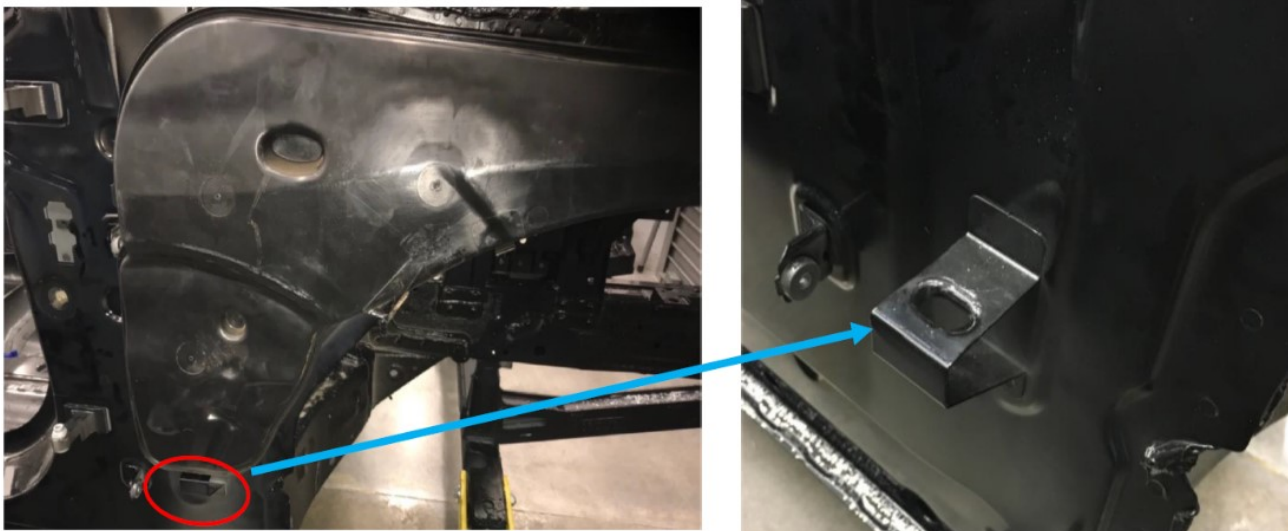
2. Access the lower mounting bracket.
