STAR ONLINE PUBLICATION

Case Number: S2308000082

Release Date: July 2023

Symptom/Vehicle Issue: No Crank, No Start with a Malfunction Indicator Lamp (MIL) on, Service Air Suspension Warning Message, Evaporative Emission System Faults or Power Inverter Module (PIM) or Power Electronic Coolant Pumps on a PHEV

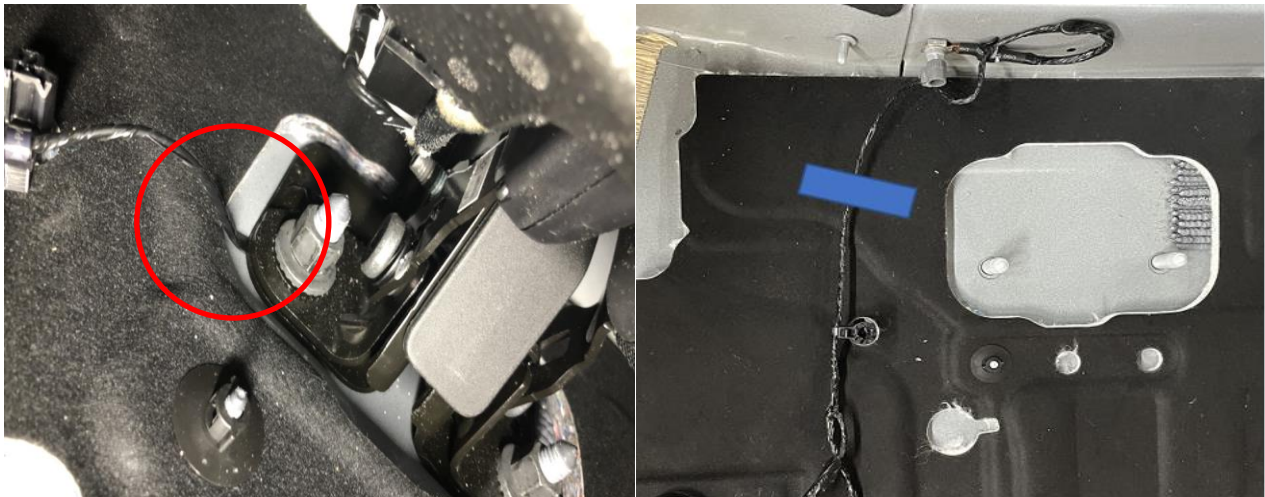
Technician Observation: The above system-related concerns may be observed after a recent repair involving the removal of the second-row seat. Diagnostic Trouble Code (DTC) U0109 Lost Communication with the Fuel Pump Control Module, Loss of Communication with The Air Suspension Control Module, Evaporative System or PHEV vehicle associated concerns with PIM or cooling system pumps may be present.

Discussion: Inspect the harness routing at the seat mounting location as seen below. Repair any pinched harness conditions using the harness repair guidelines within Service Library. Reposition and isolate the harness away from the seat mounting location before reinstalling the seat.
