STAR ONLINE PUBLICATION

Case Number: S2308000084

Symptom/Vehicle Issue: Malfunction Indicator Lamp (MIL), Stop Start Inoperative

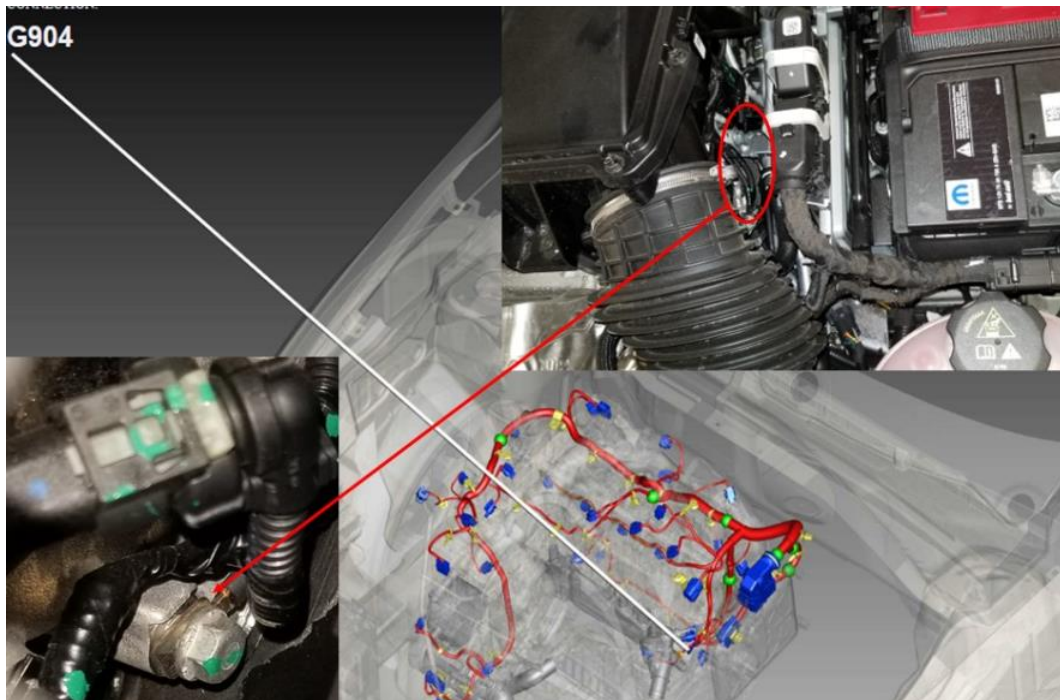
Customer Complaint/Technician Observation: The owner complains of a MIL lamp that is on, and a stop-start feature that is not working. The technician observed Diagnostic Trouble Code (DTC) P0010 Bank 1 Intake Variable Valve Timing set in the Powertrain Control Module (PCM) as stored or active.

Repair Procedure: Inspect ground location G904, clean and secure the ground at the highlighted location. No parts are required, test the operation to complete.
