STAR ONLINE PUBLICATION

Case Number: S2323000053

Symptom/Vehicle Issue: Buzz Squeak Rattle (BSR) From Door.

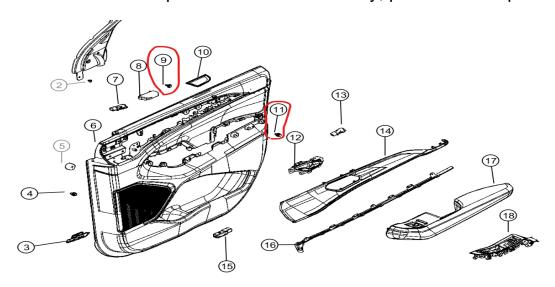
A. BSR from the door panel.

Concern could be with front or rear doors. Inspect the door panel attaching screws. Replace any missing and tighten any loose screws prior to doing any further repairs. Once complete test drive to confirm repair resolved the customer's concern. If still present on front door only, proceed to step B.
