STAR ONLINE PUBLICATION

Case Number: S2323000054

Symptom/Vehicle Issue: Buzz Squeak Rattle (BSR) Noise While Driving From Upper Forward Dash Area.

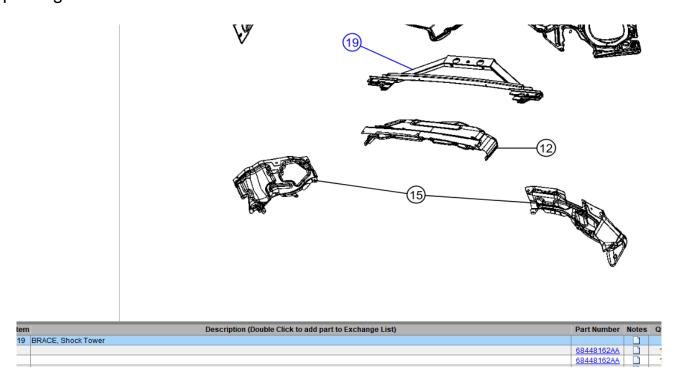
Discussion: Noise from the upper dash area could be from either side of the front cowl bulkhead. Be sure to check fastener torque on the strut tower brace in addition to inspecting the interior dash items.
