## STAR ONLINE PUBLICATION

**Case Number:** S2323000056

**Symptom/Vehicle Issue:** Buzz Squeak Rattle (BSR) from the cowl or instrument panel area over bumps or turning.

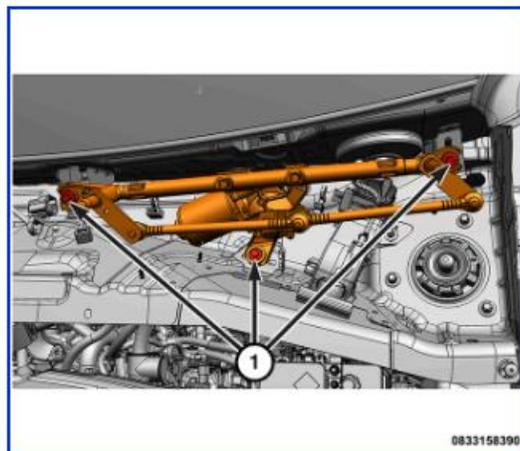
**Customer Complaint/Technician Observation:** Customer may describe a creak or rattle type noise from the dash, instrument panel, or forward cab area. Noise may happen over rough roads or in turns.

**Discussion:** Use chassis ears to aid in locating the region of the noise. Place ears on both the engine bay side and interior side of the cowl. If the noise is concentrated in the left side of the cowl below the windshield, verify all fasteners and wiper components are tight and secured.
