STAR ONLINE PUBLICATION

Case Number: S2108000193 Rev. A

Symptom/Vehicle Issue: Forward Collision Warning OFF Indicator Is Displayed In The Cluster

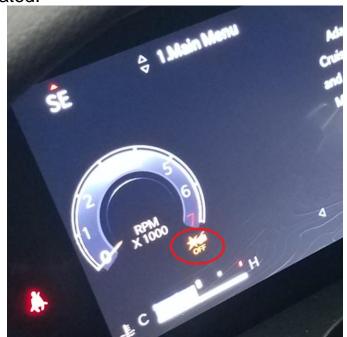
FCW OFF Indicator Light

Discussion: The vehicle may have been delivered to the dealer with the Forward Collision Warning (FCW) or Pedestrian Emergency Braking (PEB) system set to off. If either the FCW or PEB system is set to "OFF". The "OFF" indicator light for the FCW system may be illuminated.

Repair: Prior to delivering the vehicle to the customer the FCW and PEB system should be enabled. Follow the steps below to re-enable one or both systems.

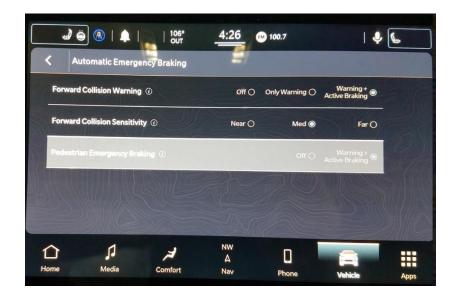
This issue may appear after a Flash Over the Air (FOTA). The Radio software may set FCW and PEB to Off as default after a FOTA.

3. Change the "Pedestrian Emergency Braking" option from Off to "Warning + Active Braking". Change the "Forward Collision Warning" to "Warning+ Active Braking".
