STAR ONLINE PUBLICATION

Case Number: S2305000002

Symptom/Vehicle Issue: Vacuum Pump Runs Continuous During Module Flash Or Is Inoperative After Recent Repair.

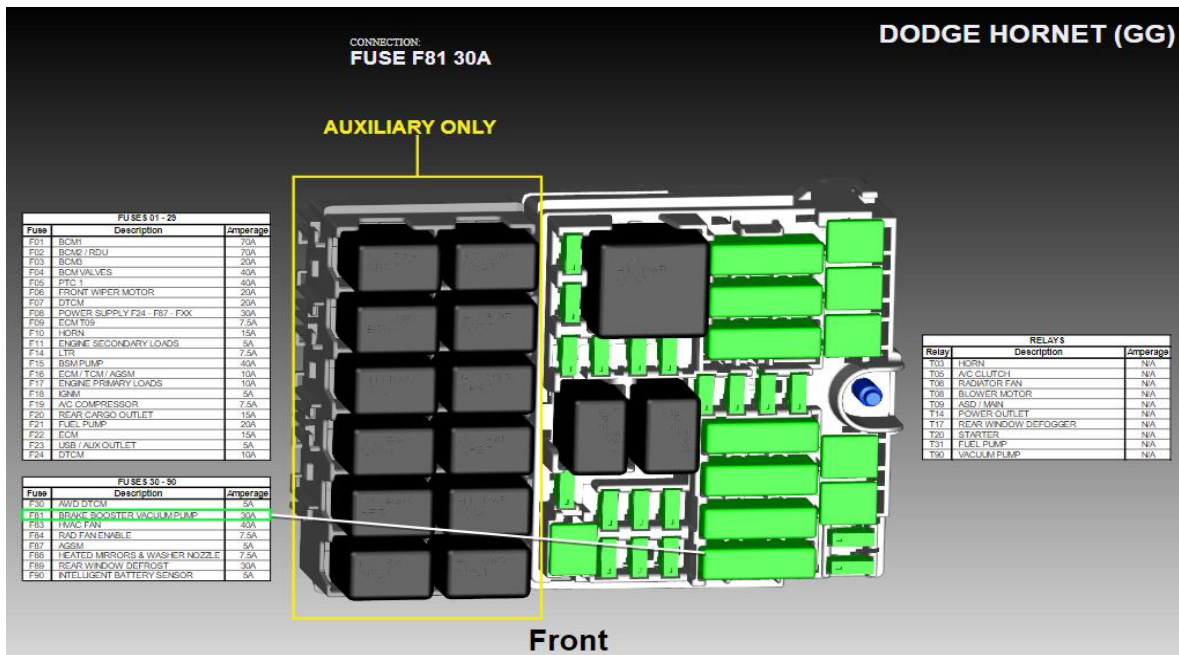
Technician Observation: Vacuum pump runs during flashing process of any module. The vacuum pump fuse may be blown and the pump is inoperative as a result.

Discussion: Service information and all publications are being updated to include an added necessary step of removing fuse F81 prior to flashing any module on GG Hornet or GC Tonale vehicles. Failure to do so may cause the vacuum pump to go into a default run mode during the flash. After flashes are complete, fuse F81 must be replaced.
