STAR ONLINE PUBLICATION

Case Number: S2109000011 REV. A

Release Date: July 2023

Symptom/Vehicle Issue: Squeak, Chirp, Or Tick Noise From The Serpentine Belt Area. Additional Diagnostics.

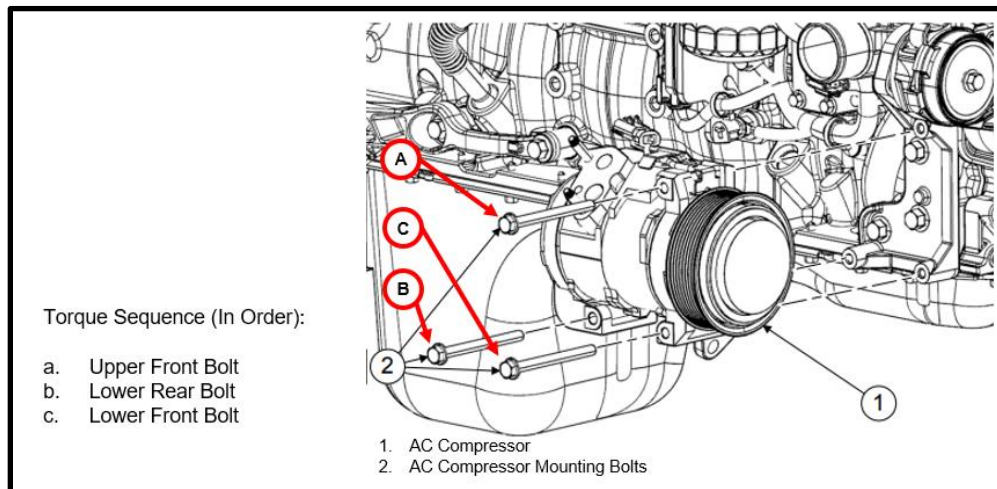
Figure 1.

The cause of the noise may be due to AC compressor alignment. Varying tolerances in the AC compressor mounting may cause slight misalignment of the belt leading to belt noise. If you receive a vehicle with this concern, please perform the following repair procedure.

4. Loosen the 3, AC compressor mounting bolts 3-4 turns. Do not fully remove the bolts.
5. Using a suitable tool push the AC compressor rearward against the mounting bolts as far as it will go.
6. While holding the compressor rearward against the mounting bolts, torque the bolts to 21 ft lbs. (28 nm) in the following sequence. Please see (**Figure 1.**)
 - a. Upper Front Bolt
 - b. Lower Rear Bolt
 - c. Lower Front Bolt
