## STAR ONLINE PUBLICATION

**Case Number:** S2308000094

**Symptom/Vehicle Issue:** Check Engine Lamp (CEL) On, Service Transmission Message

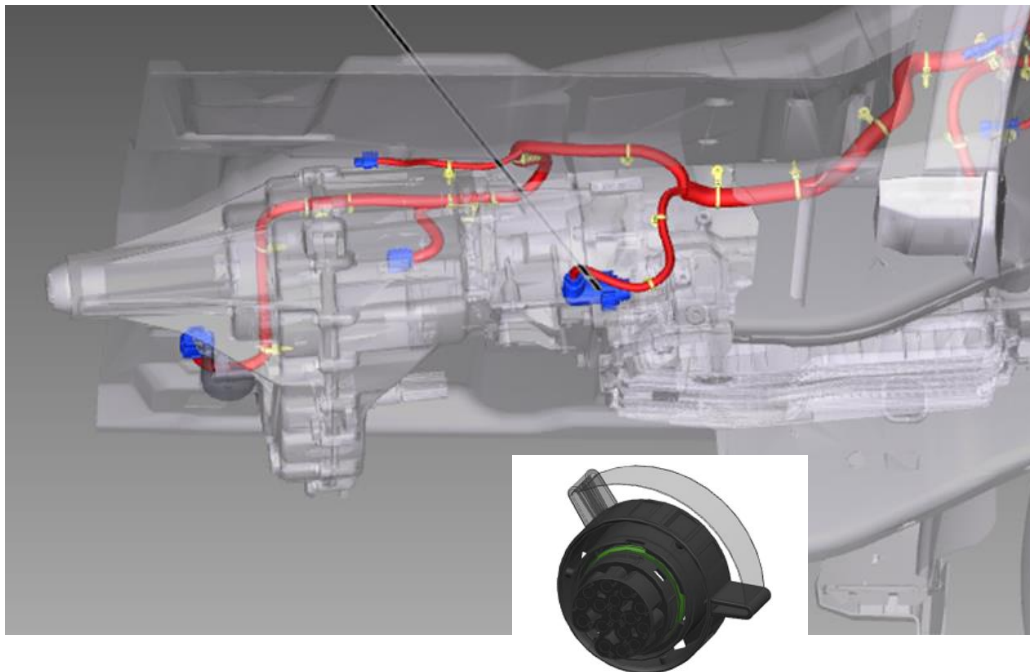
**Owner Complaint/Technician Observation:** The owner may complain that the vehicle is not shifting into gear. The instrument Panel Cluster (IPC) displays a "Service Transmission" message. The technician may find Diagnostic Trouble Codes (DTC) U0101 Lost Communication with The Transmission Control Module (TCM).

**Discussion:** Inspect connector D2735A at the transmission as shown, look for any signs of pushed-out terminals secure or replace any terminals as needed. If no signs of pushed out terminals secure the connector by its rotating collar to ensure the connector is completely seated.

**Full Repair Kit:** 68305267AA
