WARRANTY BULLETIN

NO: D-22-17

SUBJECT: 2017 – 2023 (Current) Chrysler
Pacifica (RU) and 2013 – 2016 Chrysler
Town & Country/ 2013 – 2020 Dodge
Caravan (RT) - Corrosion – **Complete
Hood Panel Warranty Claim
Simplification (Rev. A)**

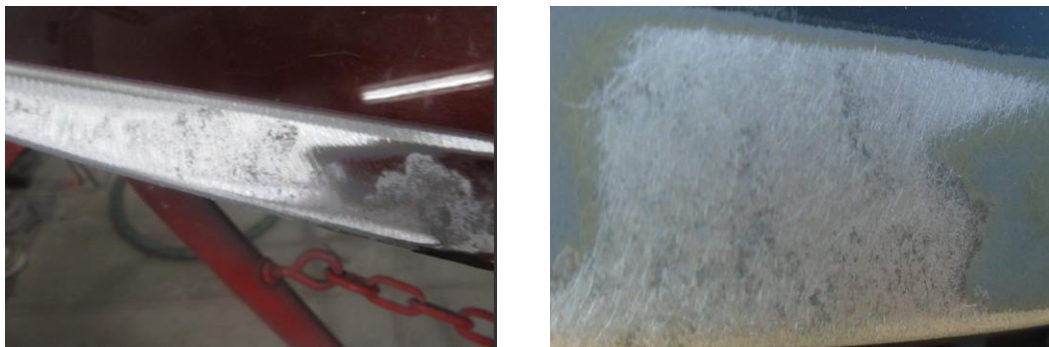
1. Perforation/ Pitting found during the sanding process (Fig. 1)

Perforation/Pitting Found After Sanding Examples (Fig. 1)

Note: If pitting is found during the sanding process, please use LOP 23-75-21-01 for up to 0.5 hours in conjunction with the 23-85 replacement LOP.

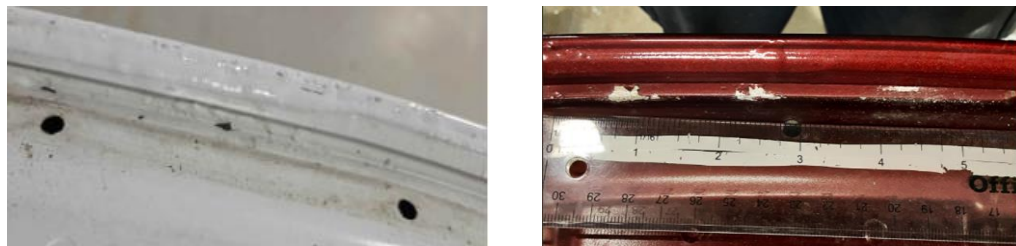
2. Corrosion found on the Hem Flange on the underside of the hood (Fig. 2)

Hem Flange Area Examples (Fig. 2)

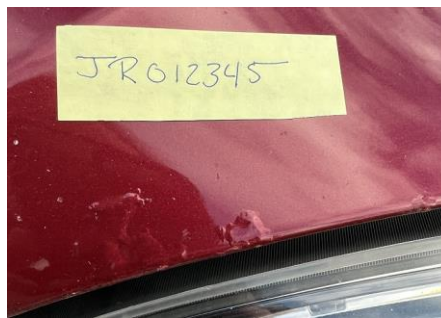
Photos to support corrosion repairs or replacement must show the VIN in the photo. The VIN can be written on masking tape, on the panel with a grease pen or a sticky note. The important part is that the VIN **MUST** be seen near the corrosion area to support the repair as seen in (Fig 3).

VIN Example (Fig. 3)
