<b>REFERENCE:</b>	<b>TSB:</b> 14-004-23 <b>GROUP</b> 14 - Fuel System	<b>Date:</b>	July 1, 2023	<b>REVISION:</b>	14-010-21
<b>VEHICLES AFFECTED:</b>	2021 – <b>**2023**</b> (JL) Jeep Wrangler <b>**This bulletin applies to vehicles built on or before March 15, 2023 (MDH 0523XX) equipped with a 2.0L I4 DOHC DI Turbo PHEV Engine (Sales Code ECX).**</b>			<b>MARKET APPLICABILITY:</b> <input checked="" type="checkbox"/> NA <input checked="" type="checkbox"/> MEA <input type="checkbox"/> SA <input checked="" type="checkbox"/> IAP <input checked="" type="checkbox"/> EE <input type="checkbox"/> CH	
<b>CUSTOMER SYMPTOM:</b>	<p>Customers may experience a Malfunction Indicator Lamp (MIL) illumination. Upon further investigation the technician may find that one or more of the following Diagnostic Trouble Codes (DTCs) have been set:</p> <ul style="list-style-type: none"> <li>• P04EC - EVAP System Large Leak Detected - Fuel Tank Side.</li> <li>• P04EE - EVAP System Very Small Leak Detected - Fuel Tank Side.</li> </ul> <p>Customers may also comment the following:</p> <ul style="list-style-type: none"> <li>• There is a "Check Gas Cap" message in the Instrument Panel Cluster (IPC).</li> </ul> <p><b>

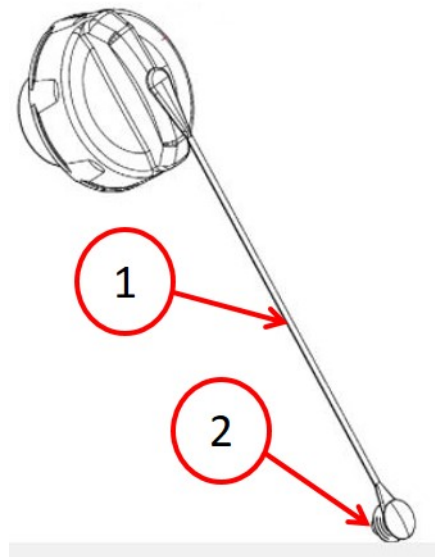
**Fig. 1**  
**Fuel Filler Cap Fastener And Tether**

<b>CAUSE:</b>	There is an air leak through the fuel filler cap to fuel filler neck seal because the fuel filler cap tether gets caught between them.

1. Open the fuel filler door.
2. Using a trim stick tool, remove the fuel filler cap tether fastener (Fig. 1) from the vehicle.

3. Remove the fuel filler cap (Fig. 1) from the filler tube.
4. \*\*Cut the existing tether near the base that is mounted in the back of housing and discard cap/tether (Fig. 1) .
5. Replace the tappet base on the fuel door with the new part.

6. Install tether onto the new mounting provision on the new tappet base.\*\*
7. Install the new fuel filler cap tether (Fig. 1) on the fuel filler cap.
8. Install the fuel filler cap (Fig. 1) on the filler tube.
9. Close the fuel filler door and verify there is no binding with the tether.
10. Clear any DTCs that may have been set.
