REFERENCE:	TSB: 03-004-23 GROUP 03 - Differential and Driveline	Date:	July 14, 2023	REVISION:	-
VEHICLES AFFECTED:	2023 (DT) RAM 1500 Pickup This bulletin applies to vehicles built on and after February 19, 2023 (MDH 0219XX) and on and before April 01, 2023 (MDH 0401XX) equipped with a 6.2L V8 Supercharged Engine (Sales Code ESD).			MARKET APPLICABILITY: <input checked="" type="checkbox"/> NA <input type="checkbox"/> MEA <input type="checkbox"/> SA <input type="checkbox"/> IAP <input type="checkbox"/> EE <input type="checkbox"/> CH	
CUSTOMER SYMPTOM:	Grease leak from halfshaft boot				
CAUSE:	Halfshaft boot leaks grease due to contact with adjoining components during assembly process

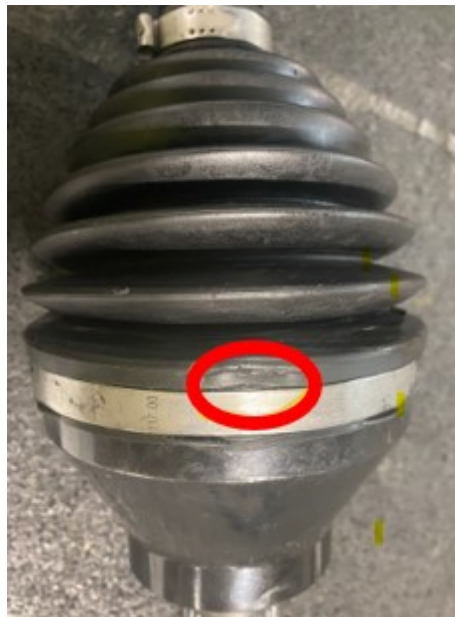
1. Raise and support the vehicle. Refer to the detailed service procedures available in DealerCONNECT/ Service Library under: 04 - Vehicle Quick Reference / Hoisting / Standard Procedure.
2. Inspect the halfshaft boots on both axles fully. Look for boot damage and/or grease (Fig. 1) .

Fig. 1
Damaged Boot

1. Replace the halfshaft. Refer to the detailed service procedures listed in DealerConnect>Service Library under: 03 - Differential and Driveline / Halfshaft / Removal and Installation.
