Technical Service Bulletin (TSB)
HVAC temperature door stuck (HVAC)

REFERENCE:	TSB: 24-007-23 GROUP 24 - Heating and Air Conditioning	Date:	July 7, 2023	REVISION:	-
VEHICLES AFFECTED:	2022 - 2023 (WS) Wagoneer / Grand Wagoneer This bulletin applies to vehicles built on and after September 01, 2022 (MDH 0901XX) and on and before March 31, 2023 (MDH 0331XX).	MARKET APPLICABILITY:			
		<input checked="" type="checkbox"/> NA <input type="checkbox"/> MEA <input type="checkbox"/> SA <input type="checkbox"/> IAP <input type="checkbox"/> EE <input type="checkbox"/> CH			
CUSTOMER SYMPTOM:	<p>Customers may experience a Malfunction Indicator Lamp (MIL) illumination. Upon further investigation the technician may find one or more of the following Diagnostic Trouble Codes (DTC)s have been set:</p> <ul style="list-style-type: none"> • B11CB-92 Front/Left Temperature Door 1 Control - Performance or Incorrect Operation. • B11CC-00 Main/Left Temperature Door 1 Travel Too Small. <p>Customers may also comment on the following:</p> <ul style="list-style-type: none"> • Driver side temperature cold when commanded to hot (or vice versa).

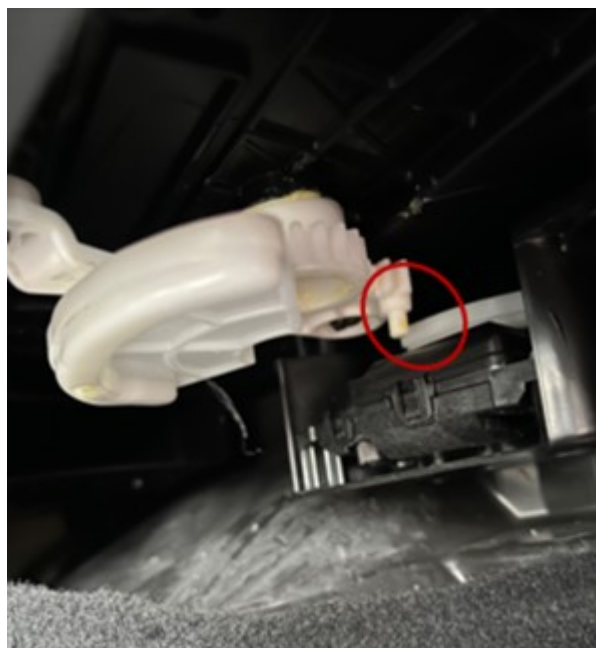
Fig. 1

CAUSE:	Possible HVAC actuator cam gear disengaged at driver temp door actuator (Fig. 1) .

NOTE: Door can be moved by hand in the up and down direction.

Pin Outside Of Actuator Cam Gear

This bulletin involves installing a three millimeter foam washer under the blend door cam gear.

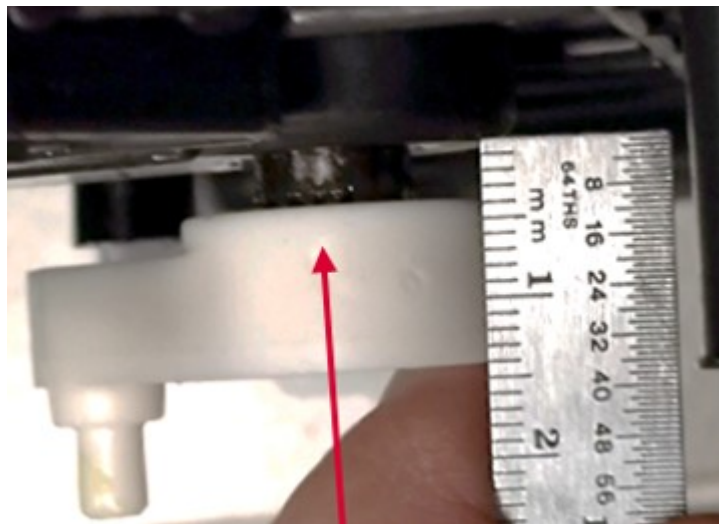
Fig. 3
Measure Gap While Pushing Cam Upwards

4. Verify the gap between the door gear and the bottom of the HVAC housing using a feeler gage or ruler.
5. Push upwards on gear and measure to see if gap is **2.5mm (0.10")** or less (Fig. 3) .

6. Is the gap **2.5mm (0.10")** or less?
 - YES>>> Proceed to [Step 1](#) of the Repair Procedure.
 - NO>>> This bulletin does not apply. Perform normal diagnostics. Use Inspect LOP (24-55-20-90) to close out this active RSU.
